Date 30.05.97	Ref. No. <b>IP00997</b>	Model <b>CM-DX1000</b>	TD
Subject <b>Standby Time Abnormally Short</b>			IRIS 1117

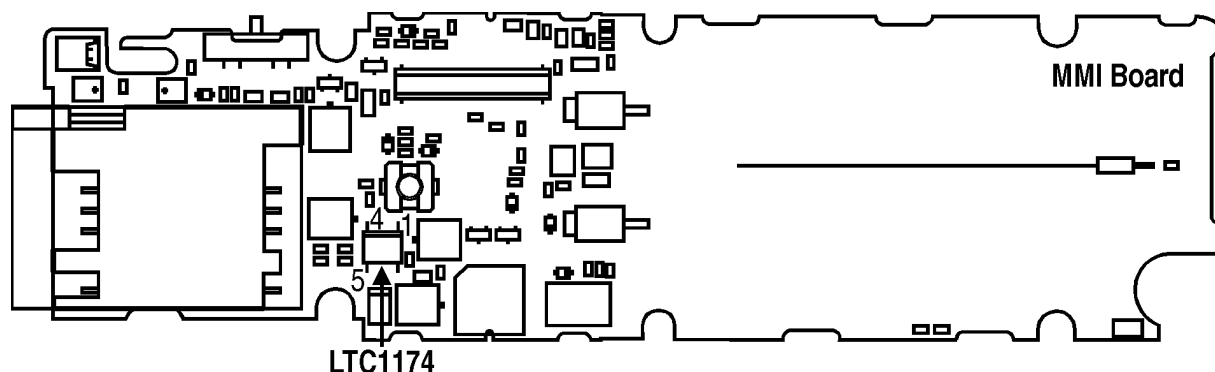
Defective IC LTC1147 on the MMI Board.

Replace IC **LTC1147** (8-759-336-22). The part is accessible on the MMI Board after removing the Lower Case Shell and the RF Unit.
