MS2650/2660 series Spectrum Analyzer

Issue Number: WP-C5AZ02082917-00

Service Note

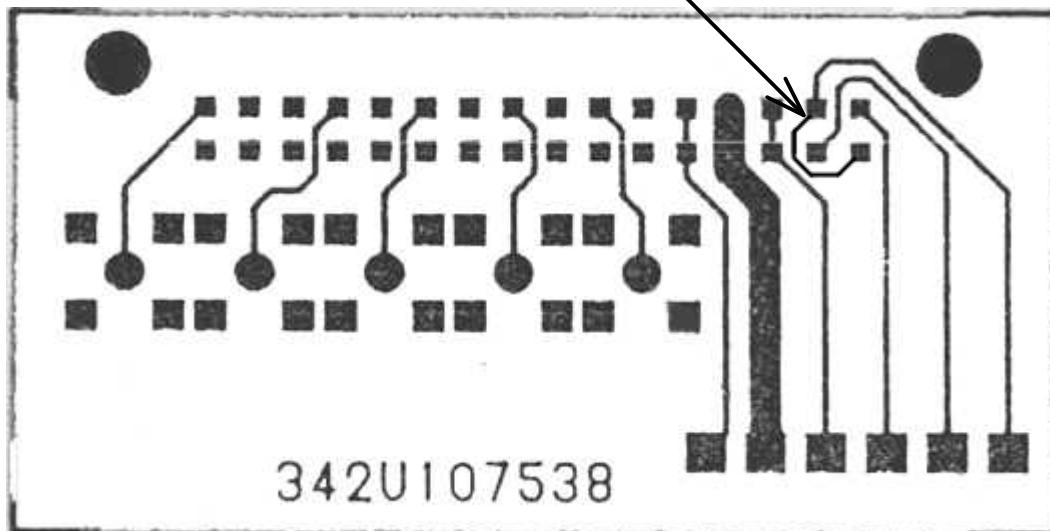
The extender cable mentioned above can not be used for 3GHz converter due to miss assembling.

Therefore 342U107538 PCB of the extender cables that have been delivered already, should be modified as below.

Short pin 1B and pin 2A with a wire.

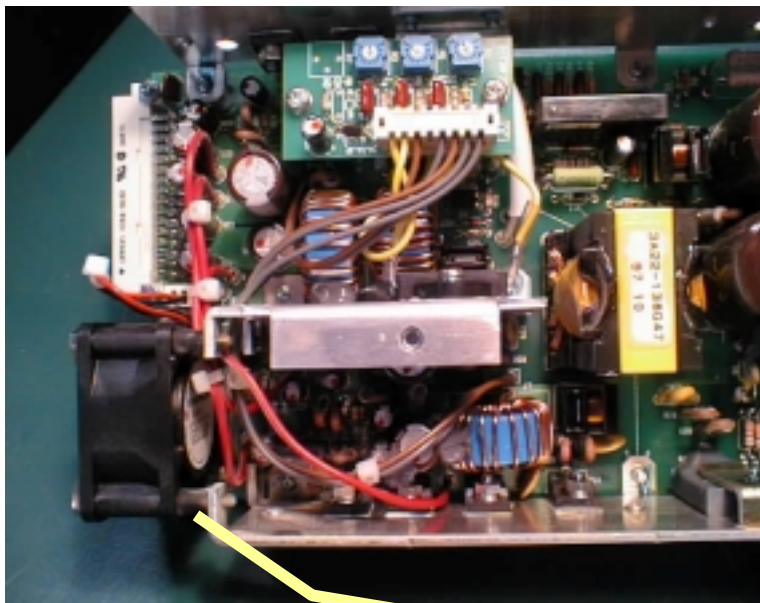
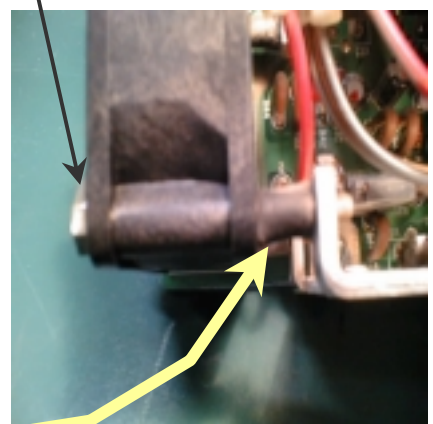
The vibration of the FAN (34Z112975 for power supply unit) is big.
Because the tightening of the screw was too strong (0.5kgfcm)
the vibration was transmitted to the package.

put the lock paints

Loosening (0.1kgfcm) the tightening of the screw and put the lock paints.

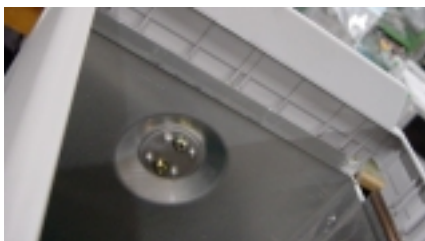
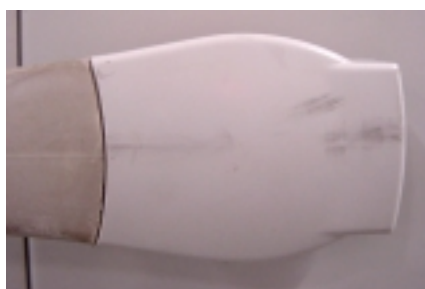
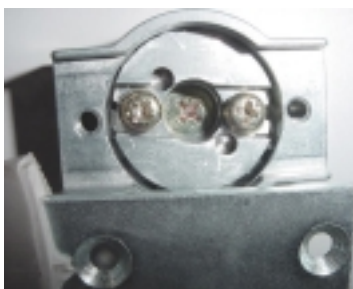
Drop of a Tilt handle Screw

The screw, which has stopped the tilt handle is dropped and installation becomes unstable. It is danger when a tilt handle dropped.

The installation screw for the tilt handle loosened.

Although fastened with standard torque (12.6kg ~ 17kgf.cm), in order that a handle is a movable part, so it loosened. Rock Paint had not painted.

Lock tightness No.262 are applied to a screw.

Lock tightness No.262

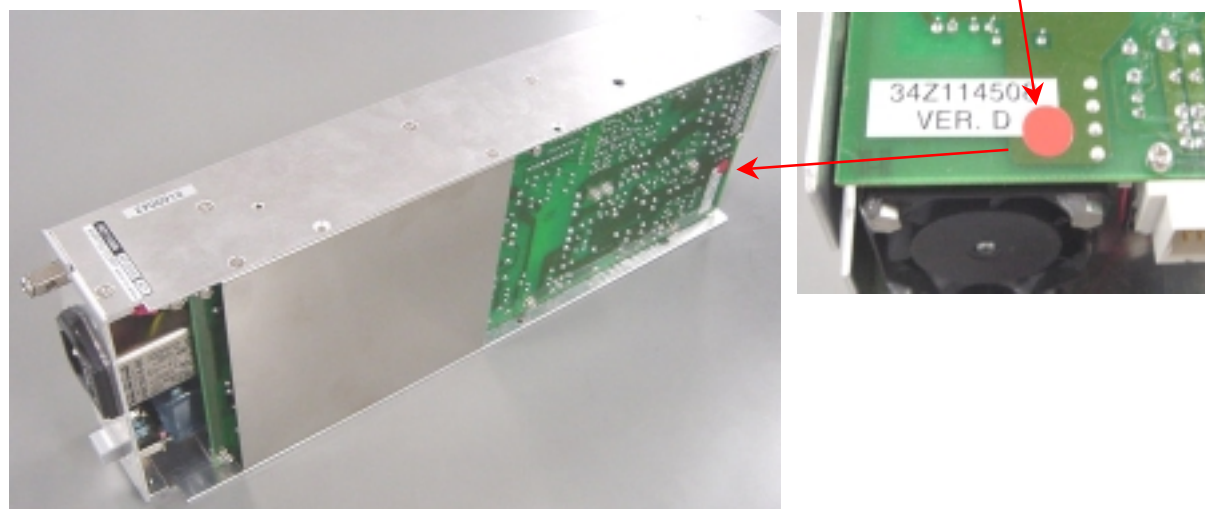
A fuse becomes open and it stops operating.

A diode may break due to the difference in the transformer characteristic.

The undermentioned photograph is an improvement power supply unit (With a red mark).

On occasions when the power supply unit before improvement breaks down, (no red mark) please return to ATSUGI factory immediately.

It exchanges free of charge.
