# Rockwell- Collins | SERVICE BULLETIN

KWM-380 TRANSCEIVER (622-5093-101)  
HF-380 TRANSCEIVER (622-3580-101)  
RECEIVER-EXCITER CIRCUIT CARD A3 (638-6908-001)

SERVICE BULLETIN NO 1

PRODUCT IMPROVEMENT

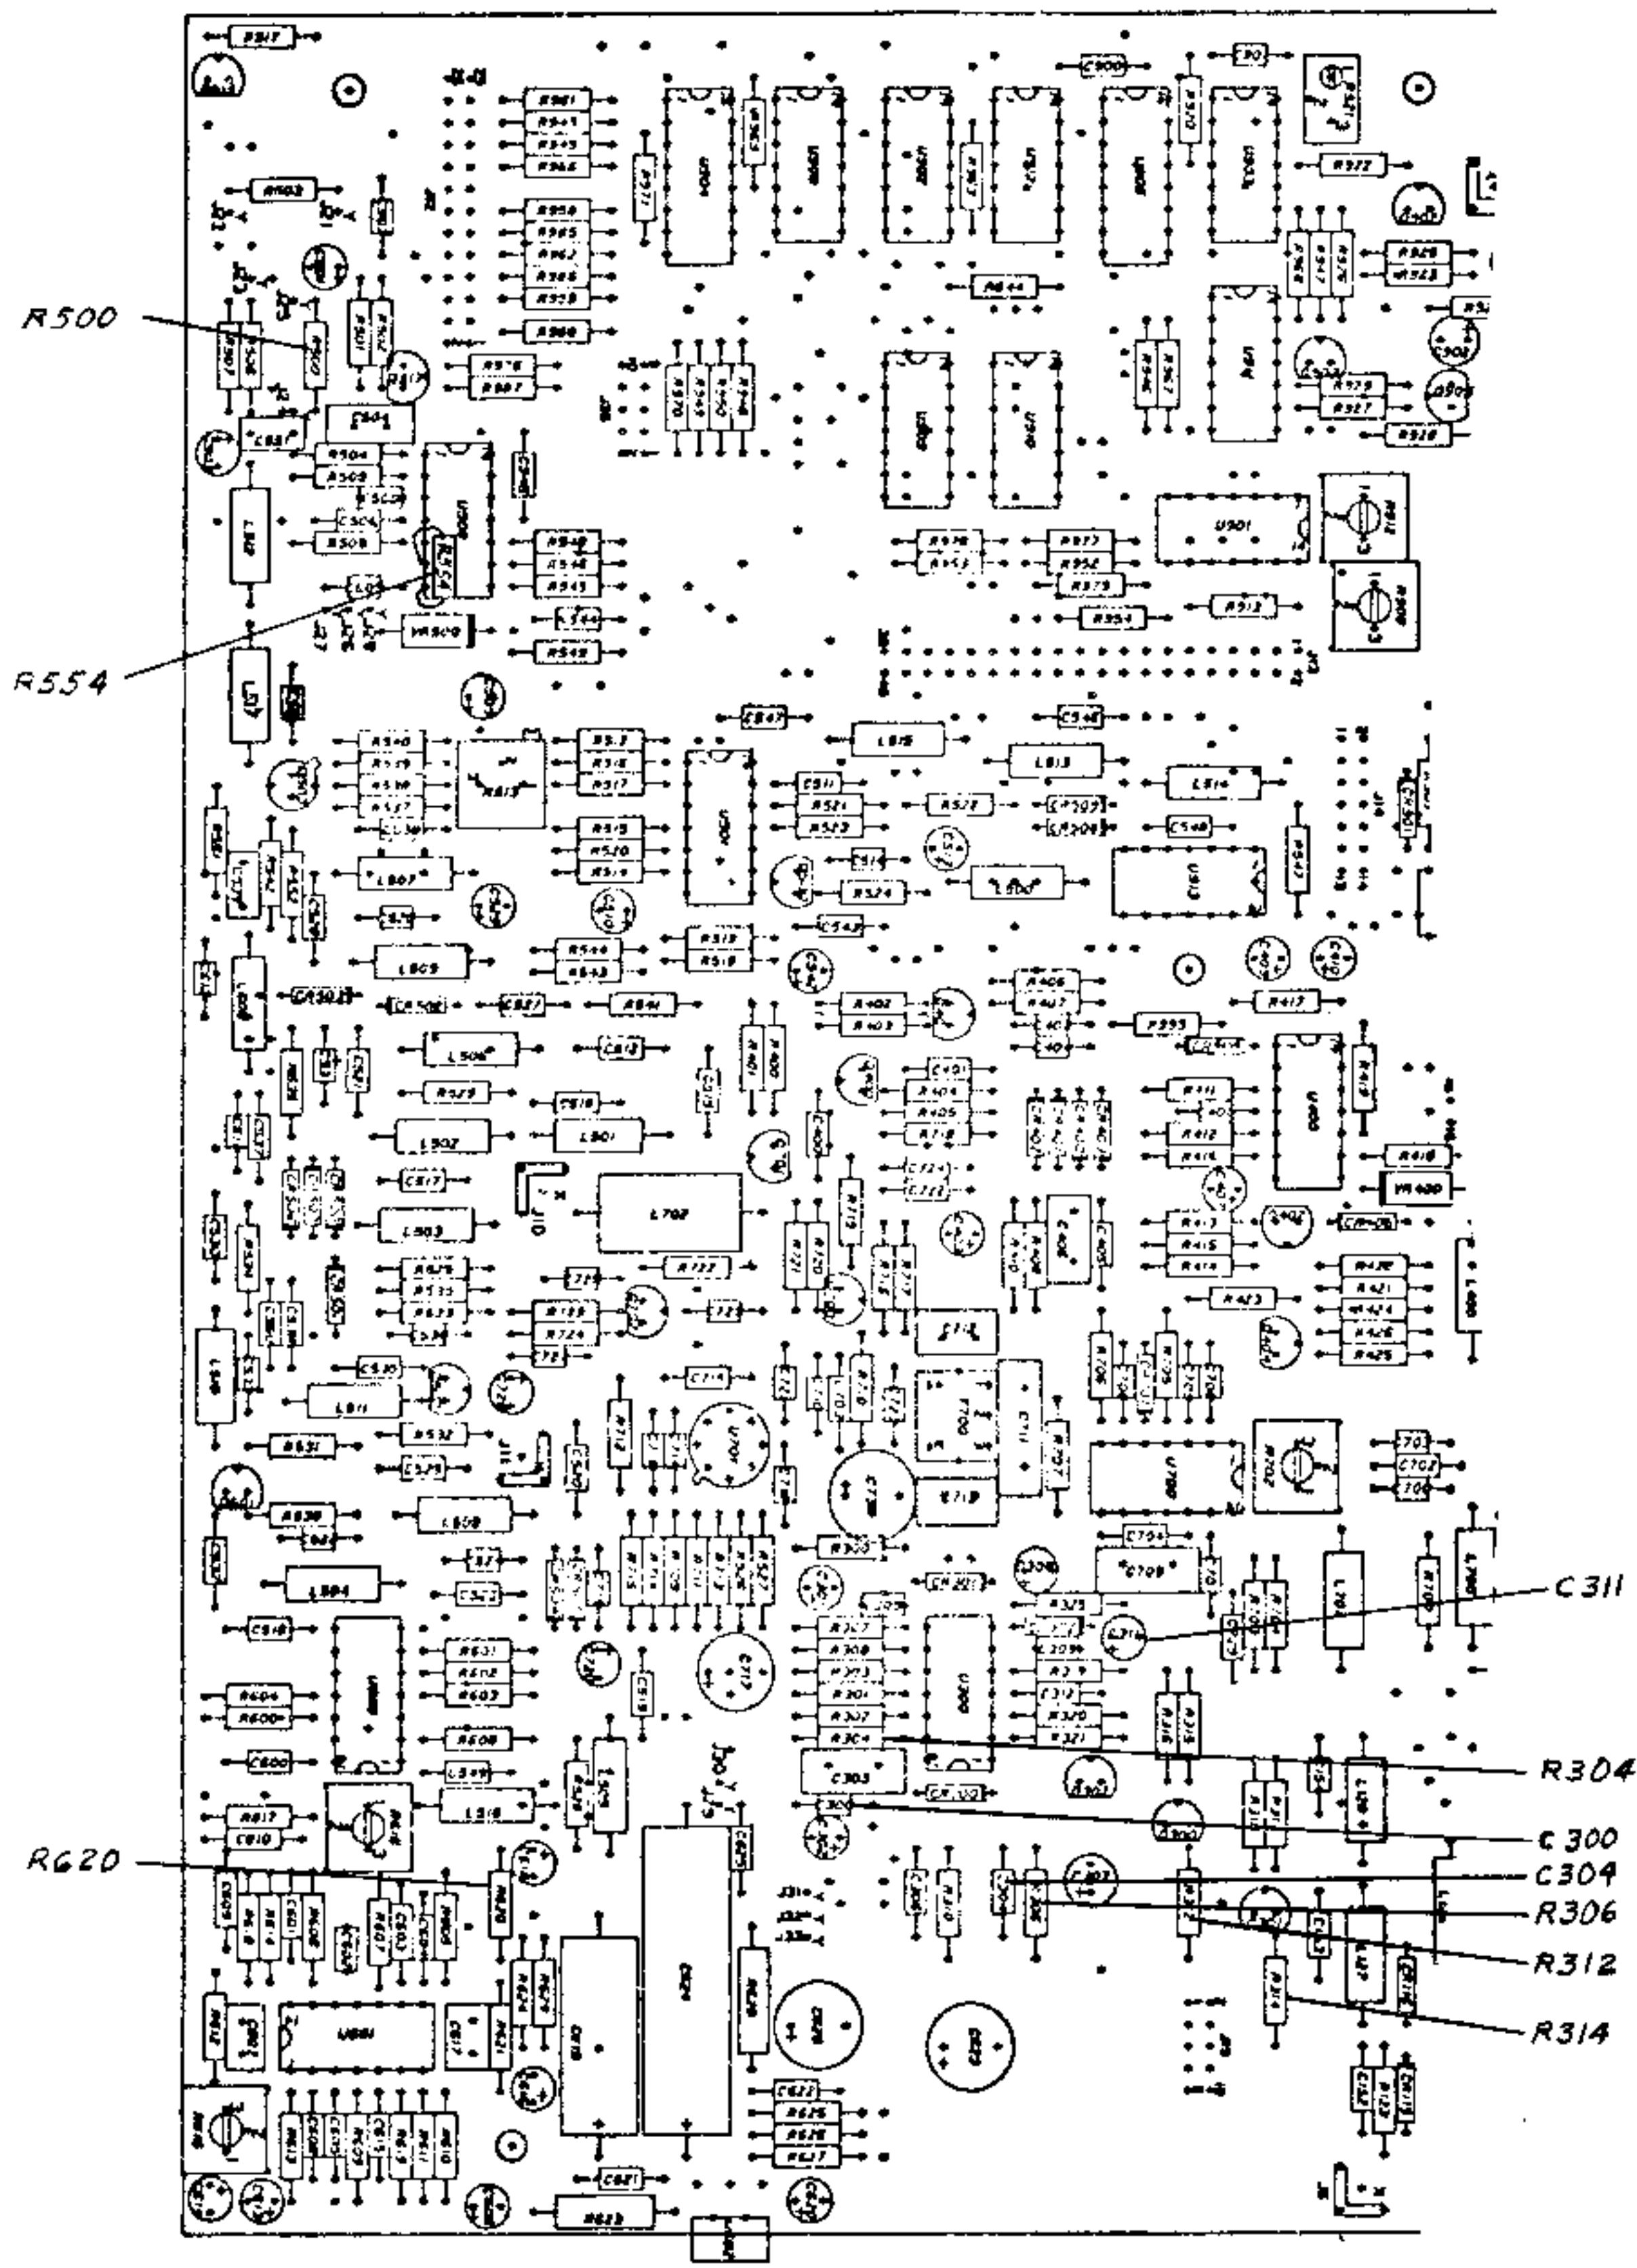
P/O Receiver/Exciter Circuit Card A3  
Figure 1

1. Mic termination is changed from 270- $\Omega$  to 3.3-k  $\Omega$  to allow either a low- or high-impedance mic to be used.
2. Mic gain is increased by approximately 18 dB.
3. A greater range of adjustment for VOX sensitivity is provided.
4. Minimum VOX delay time is decreased to less than 50 ms to allow faster semibreak in CW operation.
5. Preemphasis to VOX preamplification is added to improve SSB VOX operation.
6. Line audio (600  $\Omega$  ) output level is increased to ensure at least -10-dBm output.

- C. Remove 100-k  $\Omega$  resistor R554 and replace it with a 1-M  $\Omega$  resistor (745-2449-000).
- D. Remove 270-  $\Omega$  resistor R500 and replace it with a 3.3-k  $\Omega$  resistor (745-0767-000).

- E. Remove 33-k  $\Omega$  resistor R620 and replace it with an 18-k  $\Omega$  resistor (745-0794-000).
- F. Remove 1- $\mu$ F capacitor C311 and replace it with a 0.22- $\mu$ F capacitor (184-9102-310).

- G. Remove 1-M  $\Omega$  resistor R304 and replace it with a 100-k  $\Omega$  resistor (745-0821-000).
- H. Remove 0.01- $\mu$ F capacitor C300 and replace it with a 1000-pF capacitor (913-3281-270).

- I. Remove 0.1- $\mu$ F capacitor C304 and replace it with a 4.7- $\mu$ F capacitor (184-9102-390). The negative lead of the capacitor should be connected to the hole on the left.

- J. Remove 1-k  $\Omega$  resistor R306 and replace it with a 100-  $\Omega$  resistor (745-0713-000).
- K. Remove 47-k  $\Omega$  resistors R312 and R314 and replace them with 10-k  $\Omega$  resistors (745-0785-000).

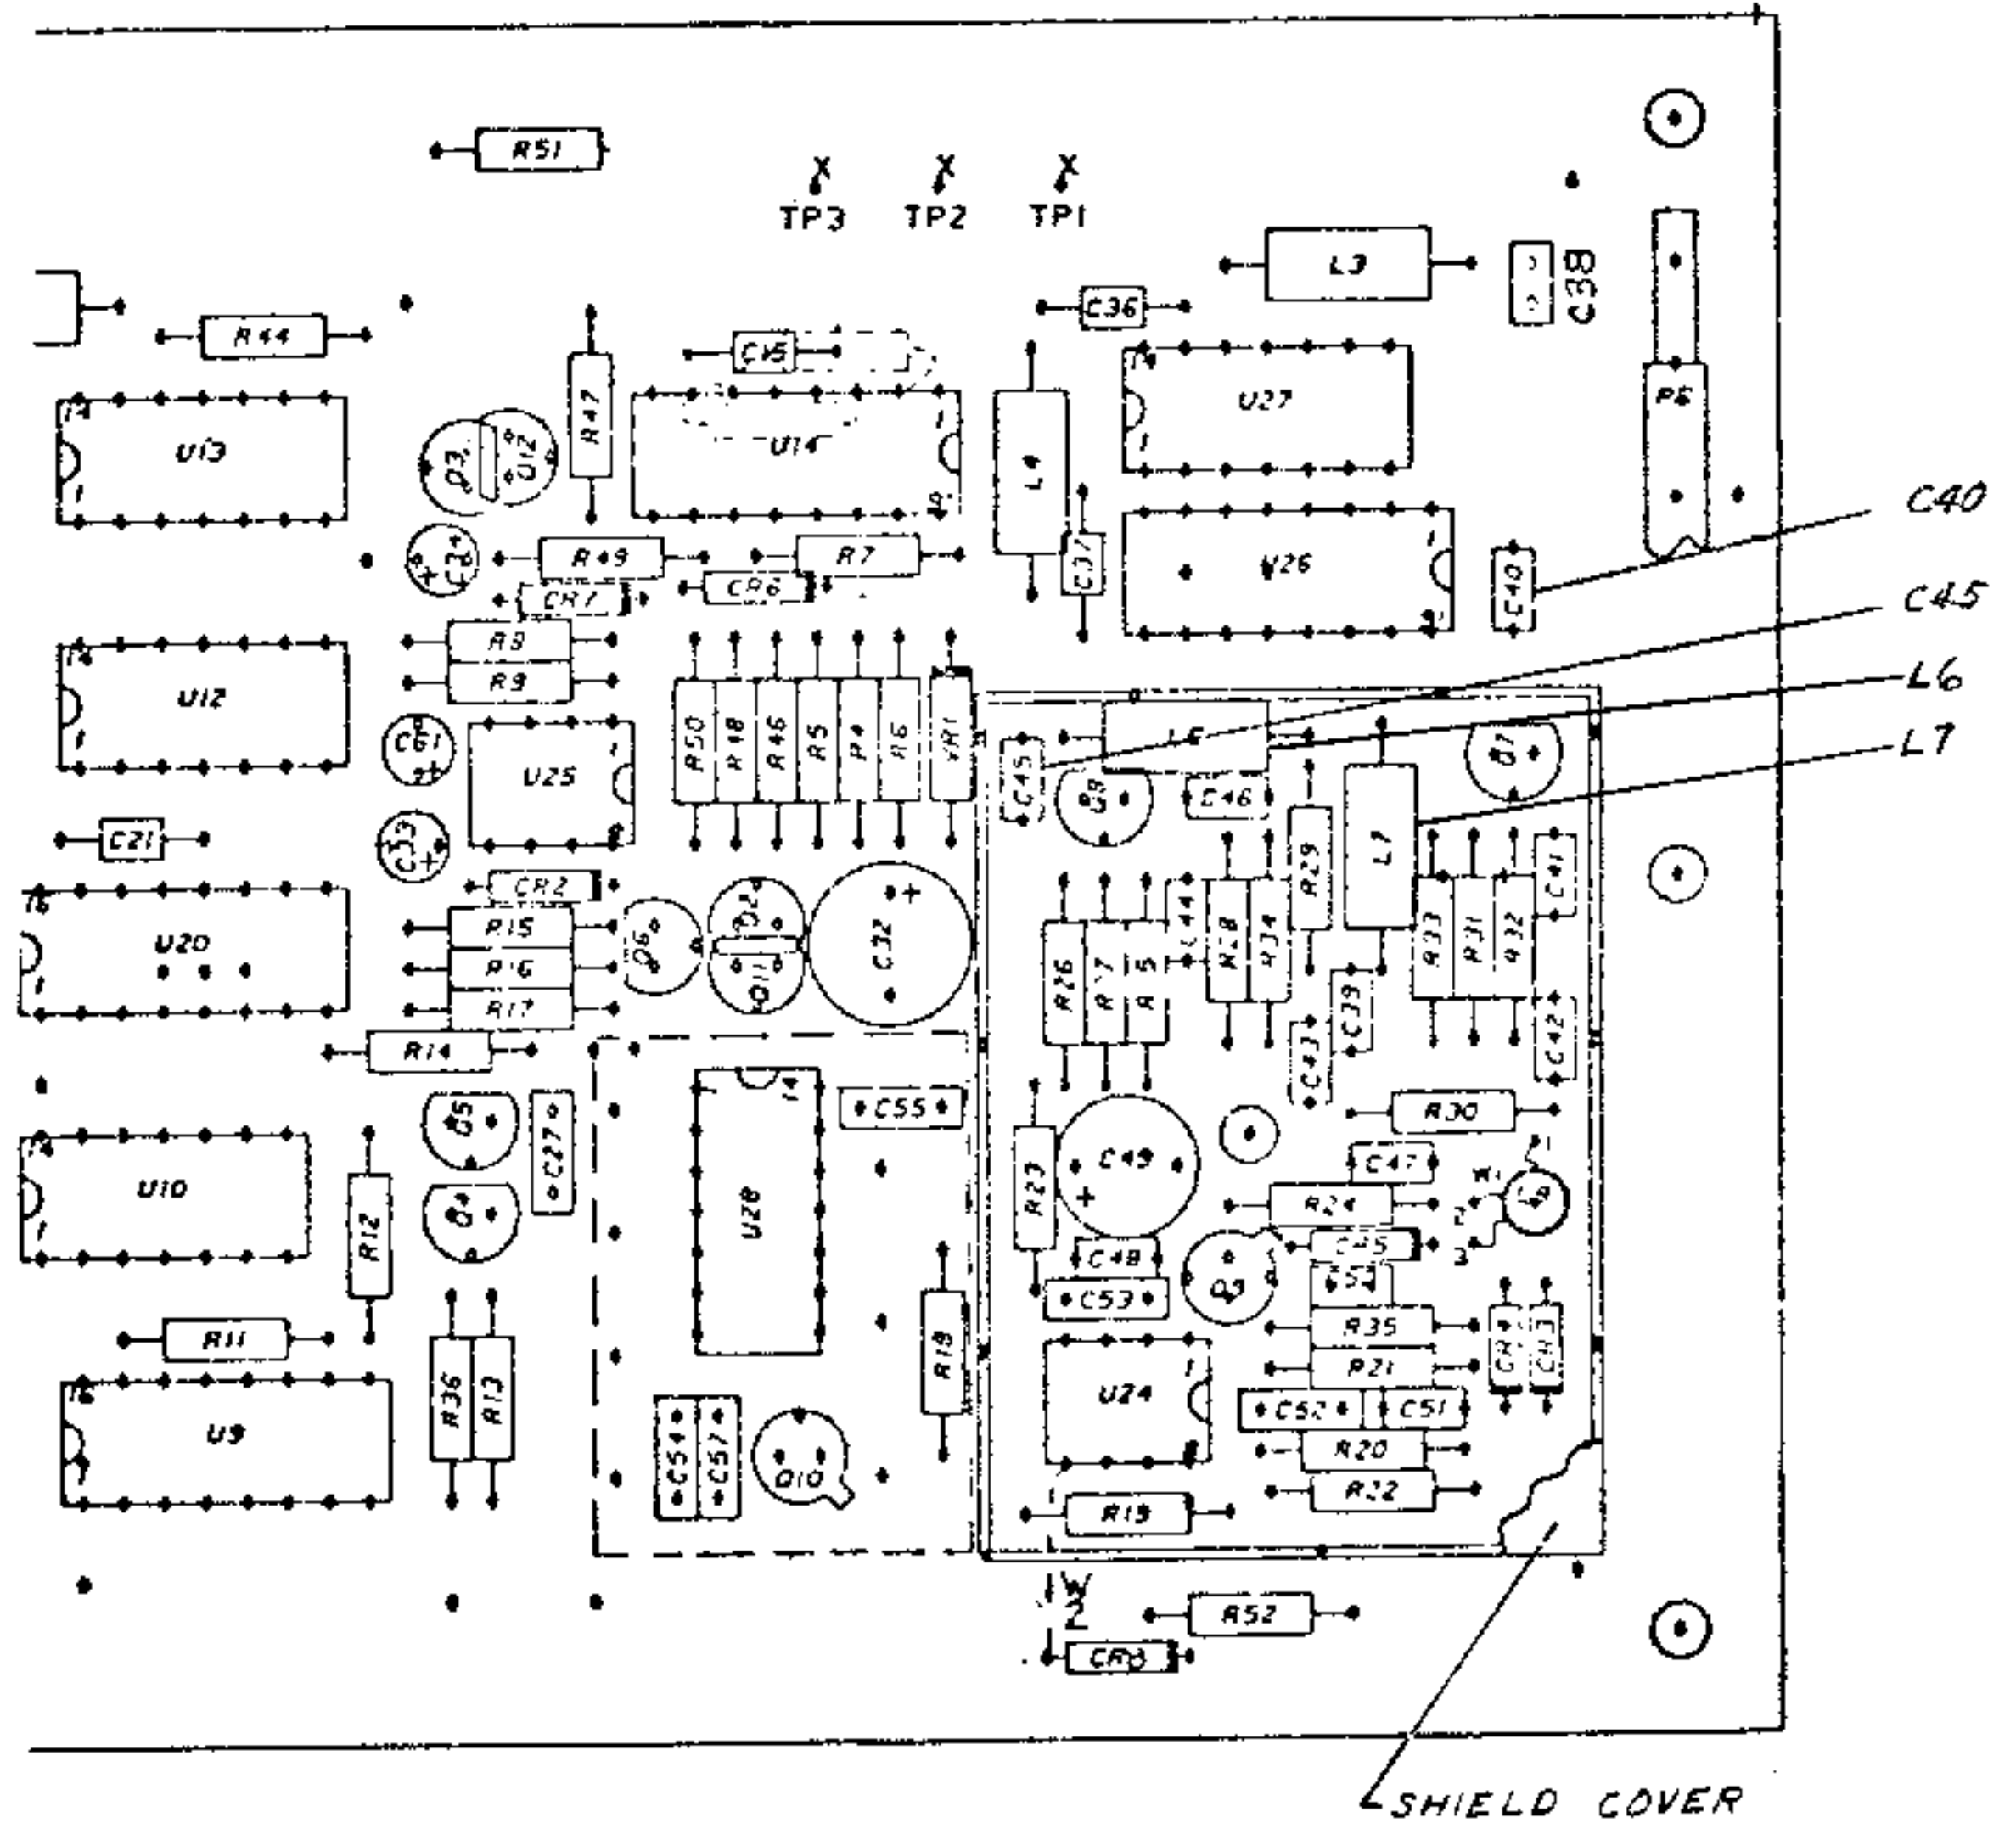
P/O Synthesizer Variable Reference Frequency Loop A5A2  
Figure 1

A frequency warble may occur at certain frequencies in some radios. The warble will usually occur at the top end of each 1 MHz band. The problem has been traced to two integrated circuits on synthesizer variable reference frequency loop A5A2. When U14 and U26 are at the low end of their specified parameters, a low rf input may cause them to miscount.

- F. Remove shield cover by removing seven screws.
  - G. Remove coils L6 and L7 and replace them with new 0.15  $\mu$ H coils (240-1562-000).
  - H. Remove capacitors C40 and C45 and replace them with new 4 pF capacitors (912-4141-080).

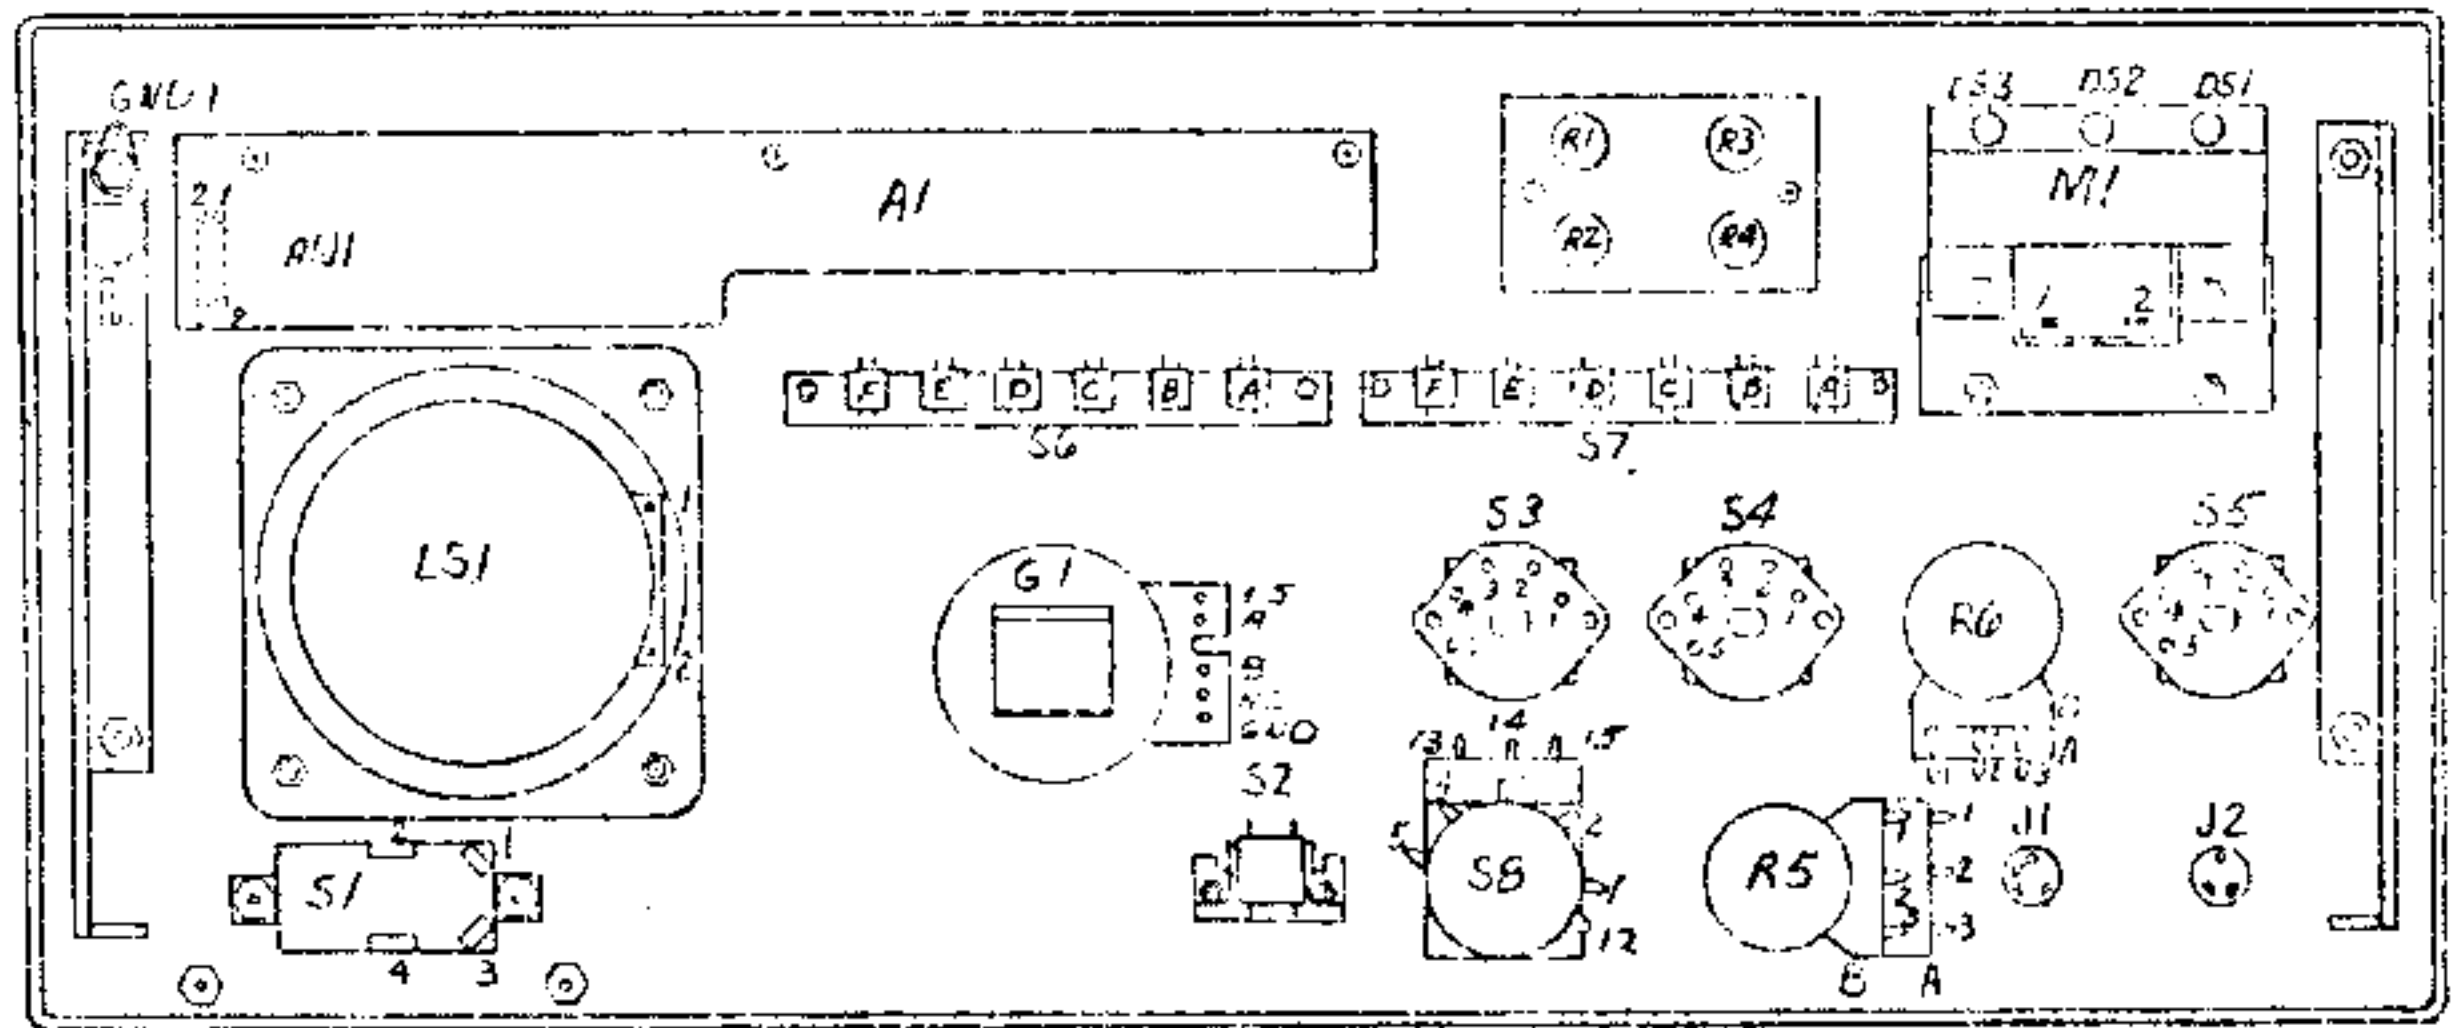
KWM-380/HF-380 Front Panel, Rear View  
Figure 1

This modification replaces the original AF RF GAIN potentiometer with a new pot that has a more conventional taper (audio 10c log, rf linear).

- C. Remove the AF RF GAIN knobs from the front panel by loosening two setscrews in each knob.

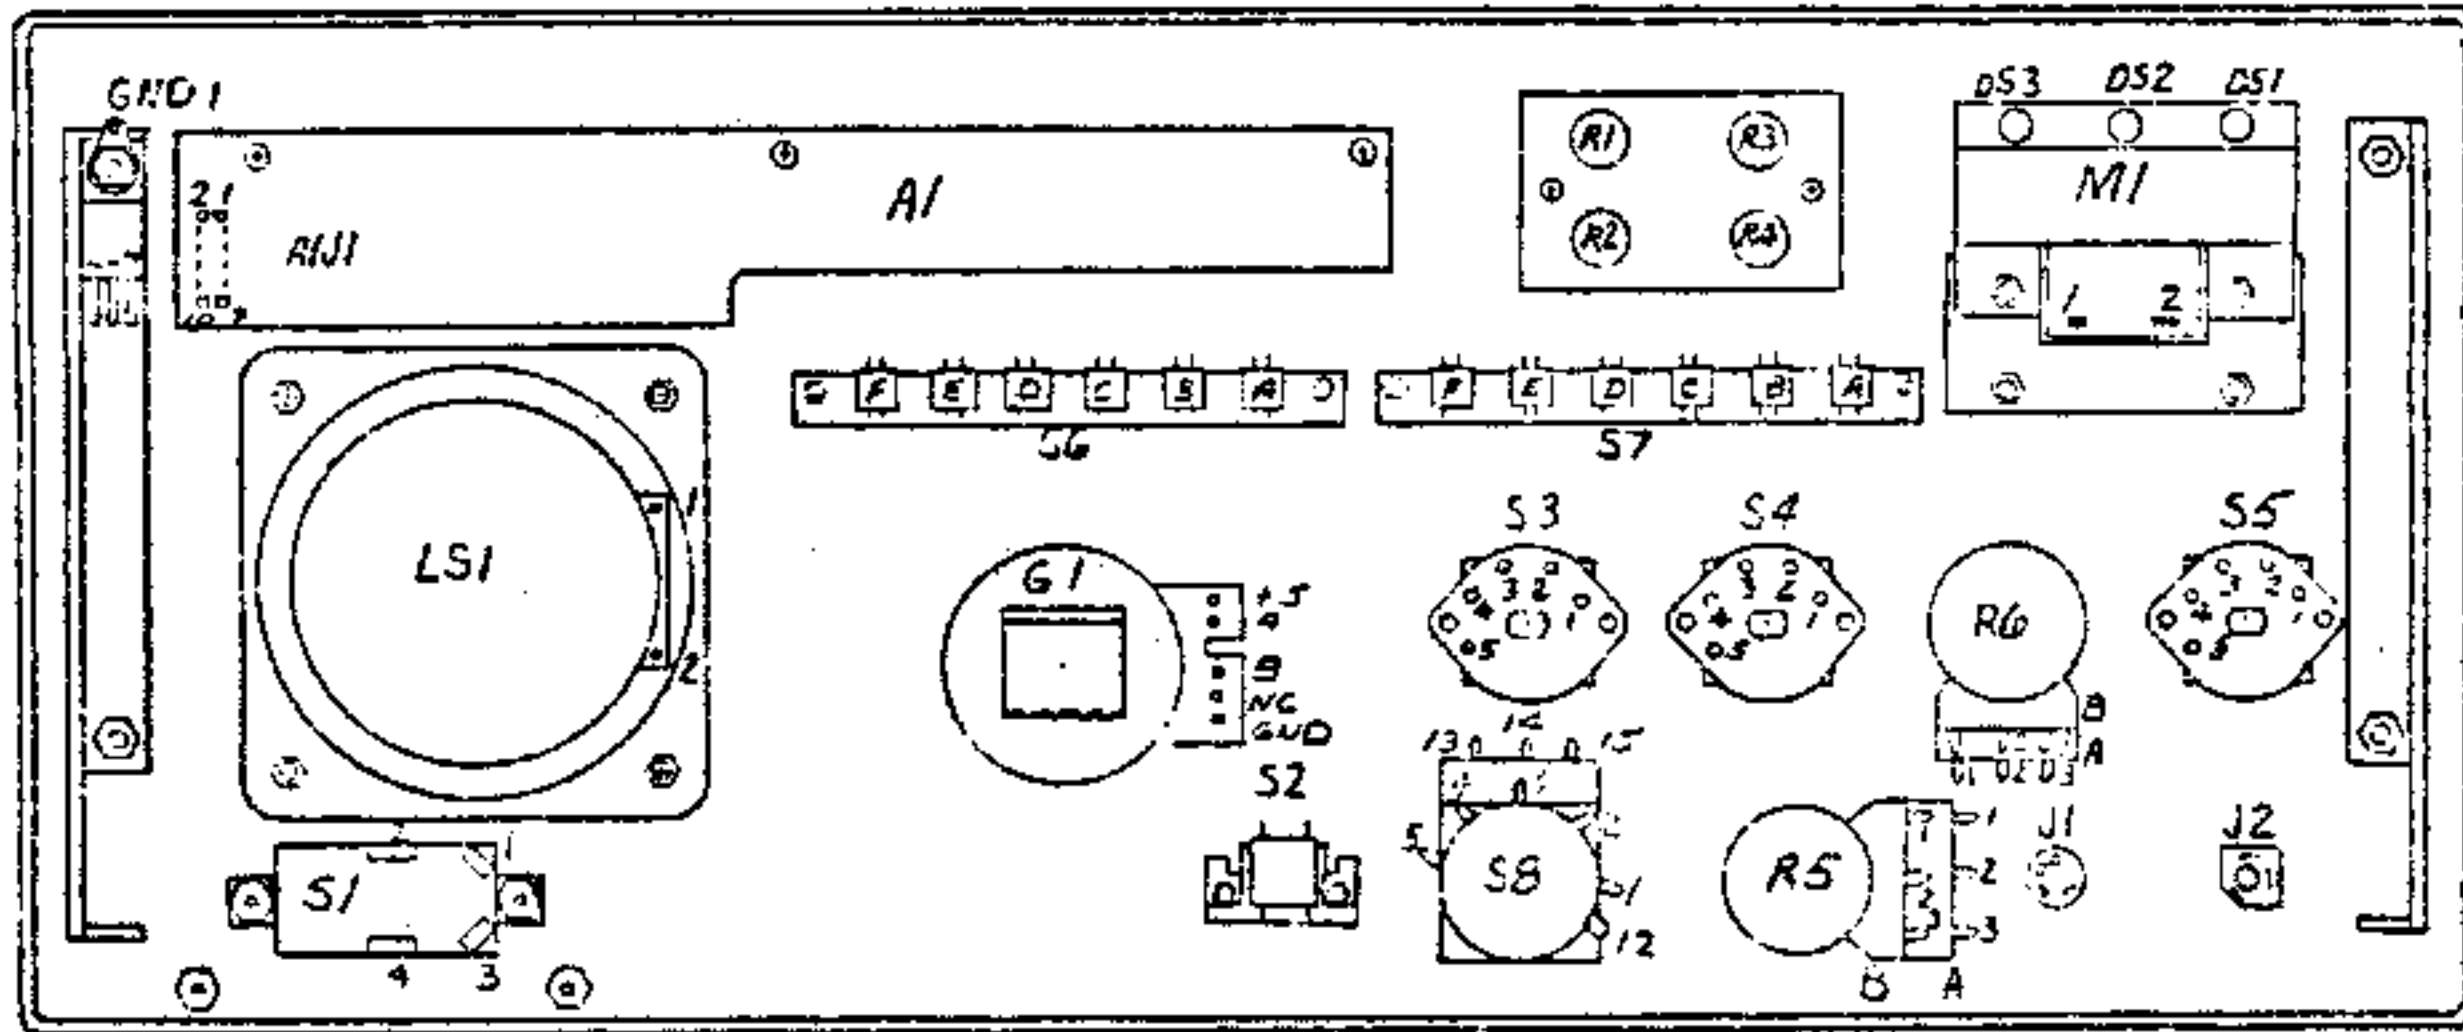
KWM-380/HF-380 Front Panel, Rear View  
Figure 1

The purpose of this service bulletin is to correct a transmit hum caused by a ground loop between the front panel and the receiver/exciter card ground plane.

This modification replaces the mic jack (J2) with a jack that has an insulated sleeve contact to break the ground loop.

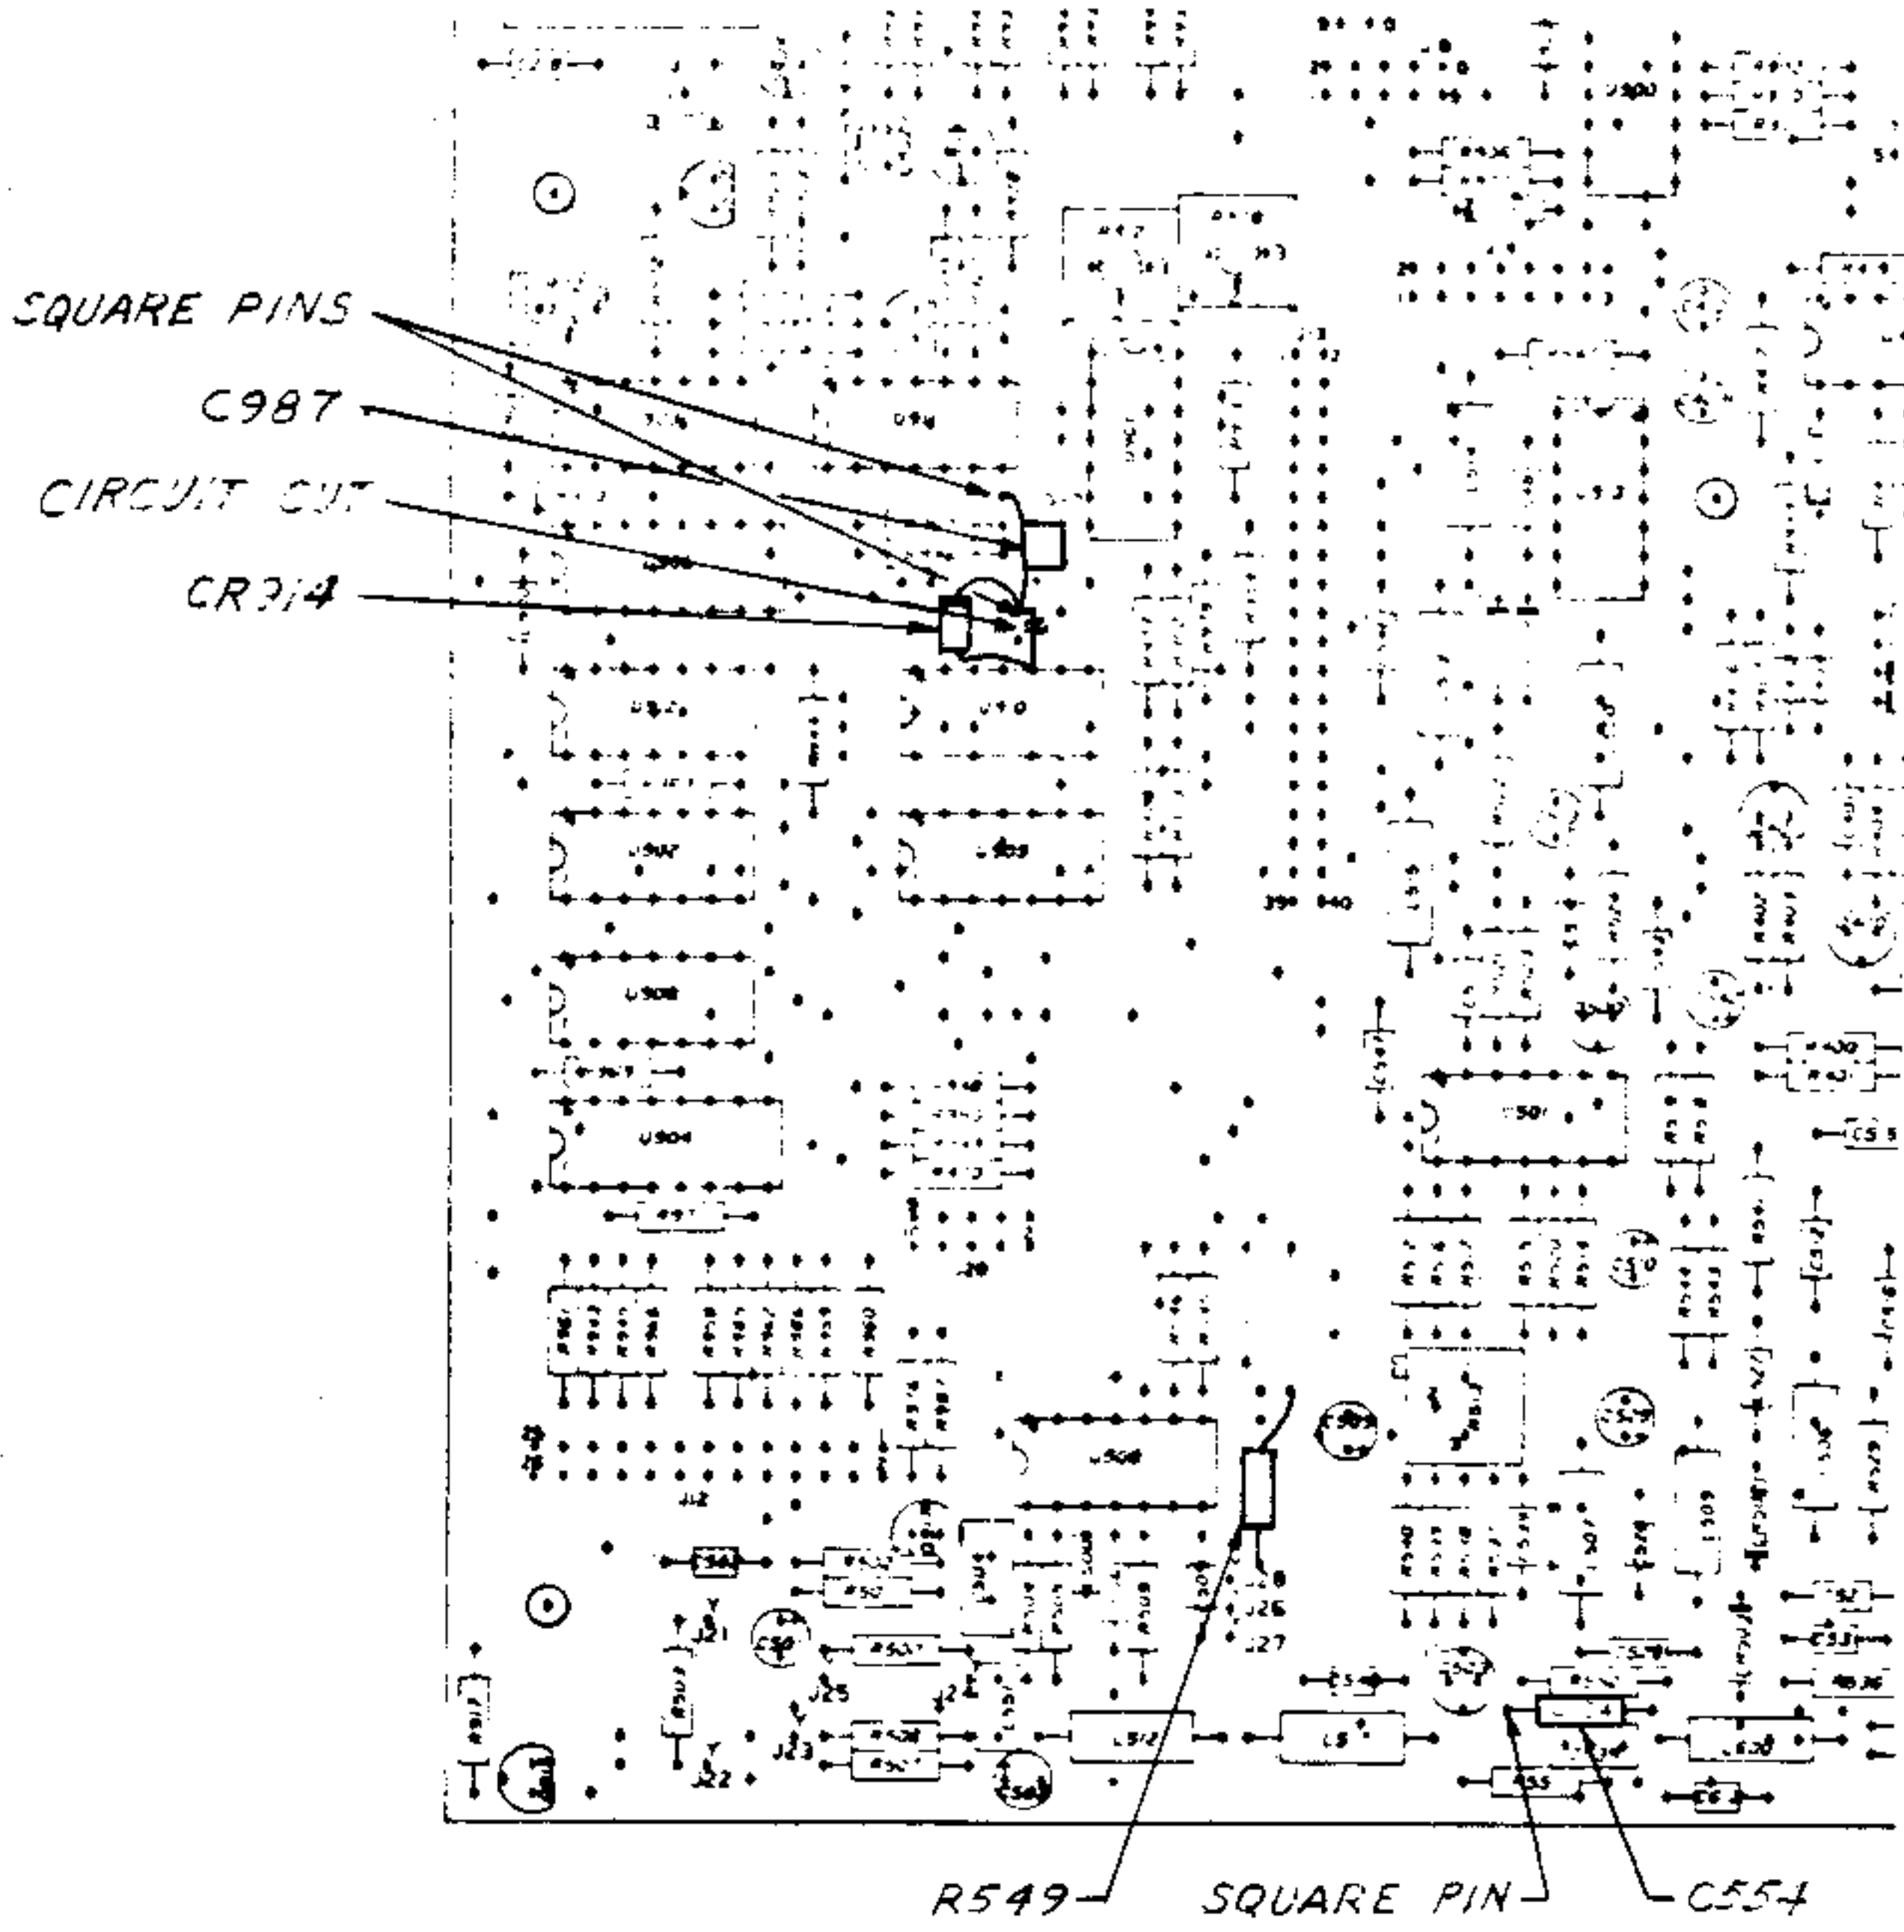
P/O Receiver-Exciter Card A3  
Figure 1

The rise and decay time of the cw envelope is less than 1 ms which may cause key clicks to be evident. This modification increases the rise and decay times to a nominal 4 ms. This still produces a hard, but click-free, waveform. This timing may be altered if desired by changing the value of R549. Increase the value to soften the keying, decrease the value to harden the keying.

**NOTE:** All changes are made to receiver-exciter assembly A3, located on the bottom of the unit. Taking care to not damage adjacent components, these modifications can be made without removing A3 from the chassis. Refer to Receiver-Exciter A3 instructions in the circuit cards section located in the back of the HF-380 and KWM-380 service manuals for location of components to be removed. Refer to figure 1 of this bulletin for location of added components. Refer to figure 2 for a schematic diagram which includes the changes made by this modification.

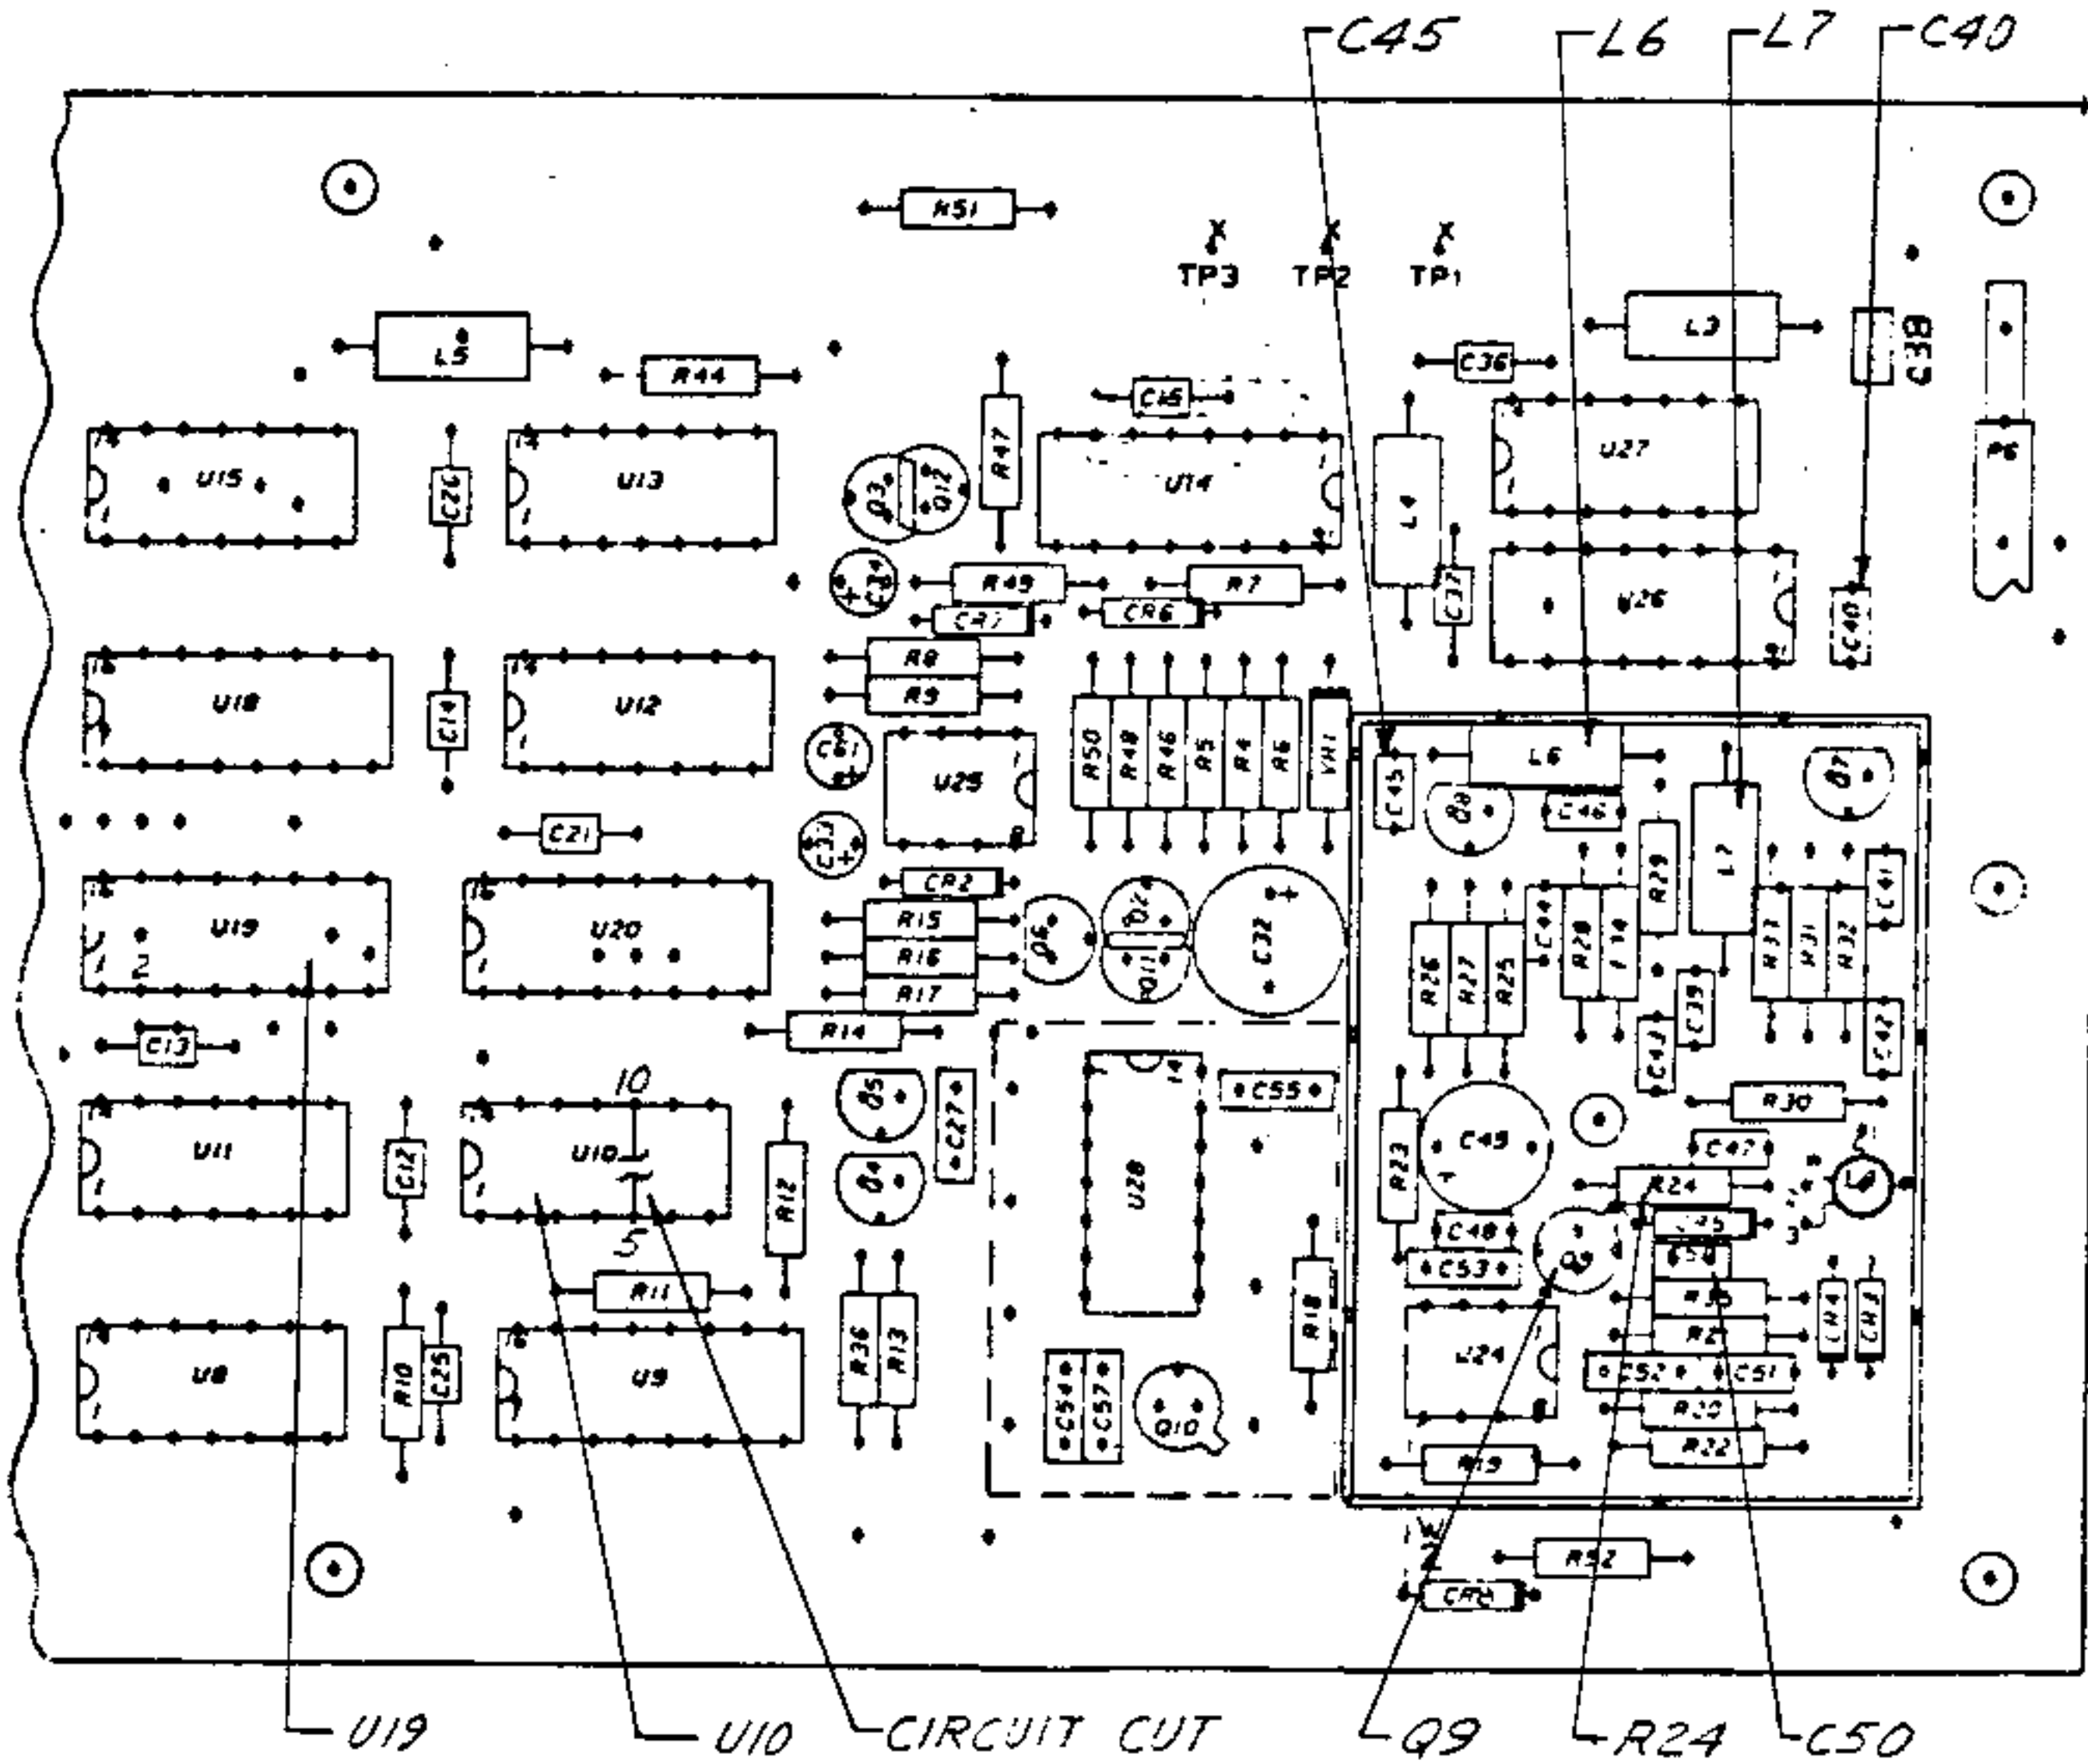
P/O Synthesizer Variable Reference Frequency Loop A5A2  
Figure 1

A frequency warble may occur at certain frequencies in some radios. The warble will usually occur at the top end of each 1-MHz band. The problem has been traced to two integrated circuits on synthesizer variable frequency loop A5A2. When U14 and U26 are at the low end of their specified parameters, a low rf input may cause them to miscount. Steps F through L of the modification procedure will correct this problem.

The synthesizer 500-Hz sidebands can be observed as a false signal 500 Hz away from a strong cw carrier when tuning with a narrow cw crystal filter. This service bulletin (steps M and N of the modification procedure) reduces the 500-Hz sideband level on the synthesizer output (first receiver mixer local oscillator).

- F. Remove 4-pF capacitor C40 and replace it with a 12-pF capacitor (912-4141-120).
- G. Remove 4-pF capacitor C45 and replace it with a 12-pF capacitor (912-4141-120).
- H. Remove transistor Q9 (2N5486) and replace it with a 2N5397 transistor (352-0998-010).
- I. Remove 0.15- $\mu$ H coil L6 and replace it with a 0.10- $\mu$ H coil (240-2723-140).
- J. Remove 0.15- $\mu$ H coil L7 and replace it with a 0.10- $\mu$ H coil (240-2723-140).
- K. Remove 47-pF capacitor C50 and replace it with a 27-pF capacitor (913-1098-570).
- L. Remove 154- $\Omega$  resistor R24 and replace it with a 56- $\Omega$  resistor (745-0704-000).
- M. On the bottom of the card, cut the circuit trace which connects U10-5 to U10-10.
- N. Install a jumper wire (428-0282-050) from U19-2 to U10-5 on the bottom of the card.
- O. Mark SB 16 on the circuit card near the part number.
