PRODUCT(S):	SFP: PIXMA iP3000/4000/4000R/5000/6000D/8500 MFP: PIXMA MP750/760/780
AFFECTED:	All Units
DESCRIPTION:	5 Alternating Blinks (SFP) / ##356 (MFP) - ASF Cam Sensor Error
SOLUTION(S):	Adjust the Screws & Main Case Unit

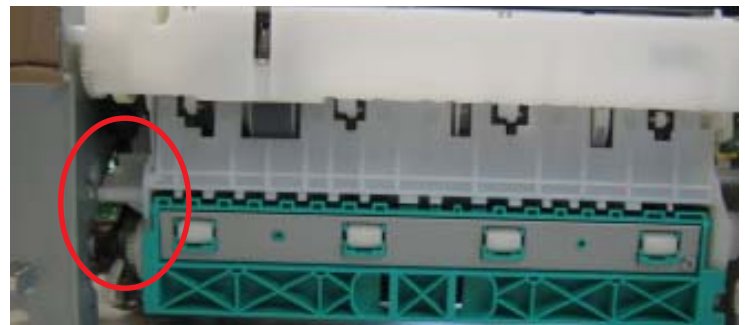
FIGURE 1: PLASTIC GUIDE ON THE BOTTOM OF MAIN UNIT

- Step 4: Turn the Main Unit over (upside down) and place on work surface as shown in Figure 1.
- Step 5: Inspect the ASF section of the Main Unit for a gap between the white plastic guide and the Chassis (Figure 2). *Note:* The size of the gap varies. Even if the gap is not visible, complete the steps below.

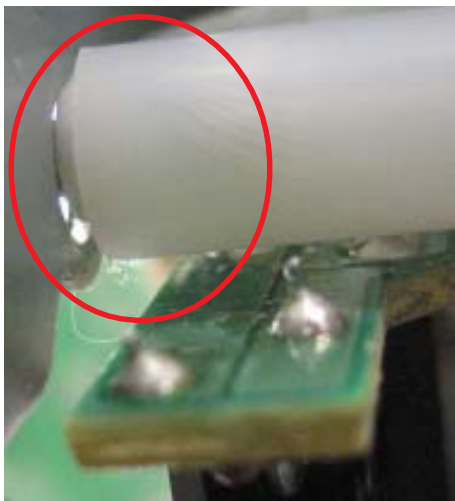
Movement (i.e. from shipping) may cause the plastic guide to move away from the chassis. When this occurs, the gears cannot rotate properly causing a grinding noise and 5 alternating blinks (SFP) or ##356 (MFP) - ASF Cam Sensor Error.

FIGURE 2: INCORRECT
GAP BETWEEN PLASTIC GUIDE & FRAME

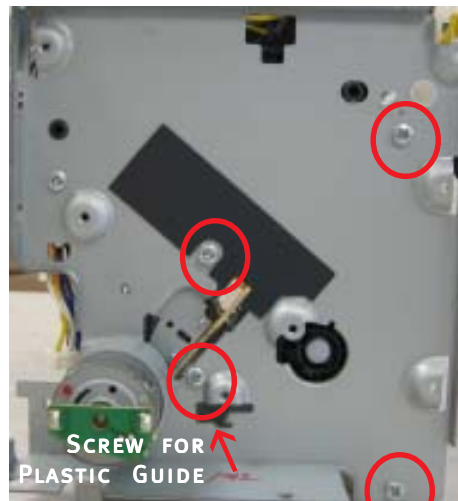
FIGURE 3: FOUR MOUNTING SCREWS
(RIGHT SIDE UP)

- Step 6: Disconnect the appropriate cables and remove the Logic Board from the Chassis.
- Step 7: Loosen (do not remove) the 4 mounting screws (the mounting screws can be found behind the logic board) on the Chassis as shown in Figure 3.

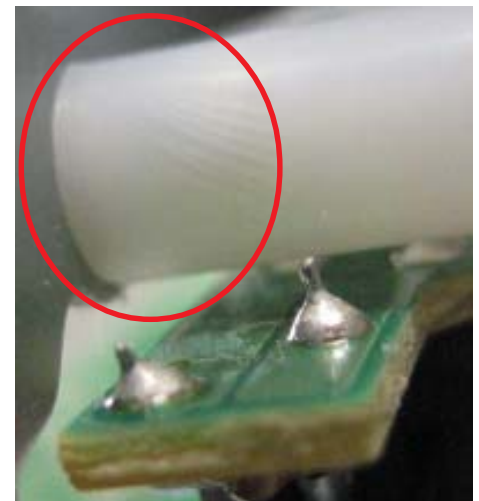
FIGURE 4: CORRECT
NO GAP BETWEEN PLASTIC GUIDE & FRAME

- Step 8: Re-seat the white plastic guide so it sits flush against the Chassis. The tip of the white plastic guide should sit slightly inside the mounting screw hole. When seated correctly, the gap will no longer be present as shown in Figure 4.
