Service Bulletin

Date 06.02.98	Ref. No.	Model CMD-X2000	TD
Subject			IRIS
Echo Problem			2551

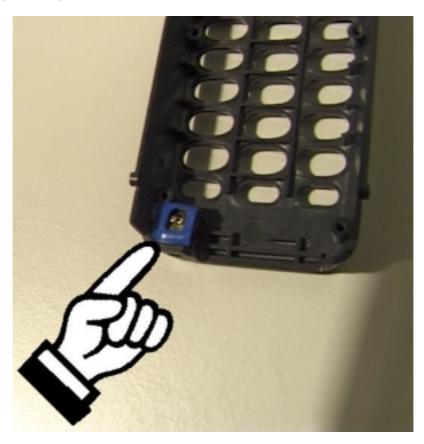
During a telephone call originating from the CMD-X2000, the called party can hear the calling party echoing.

- The original "Cushion, Microphone" is placed on the MMI Board, over the microphone.
- The replacement part, however, should be placed directly on top of the microphone on the front cosmetic, NOT on the MMI Board.
- After mounting the "Cushion, Microphone" on top of the microphone, peel off the protection plastic on top in order to allow the "Cushion, Microphone" to stick to the MMI Board when the set is reassembled.
- When ordering the part, two pieces will be delivered.

Replace the "Cushion, Microphone" with the new part 3-020-342-01.
