Date 07.02.97	Ref. No. IP00297	Model CM-DX1000	TD
Subject Disassembly of Set			IRIS

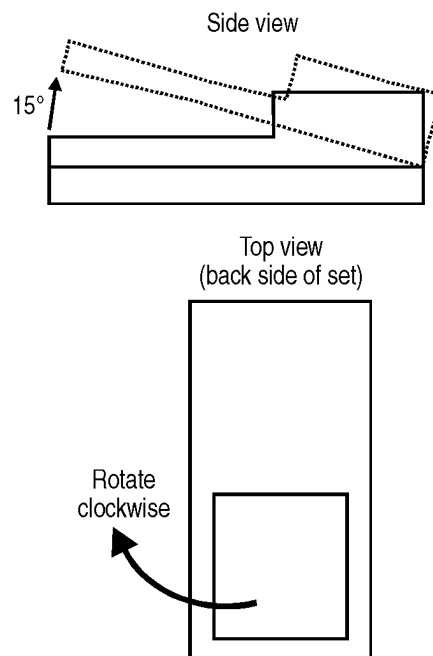
Disassembling the CM-DX1000 may lead to damage of the Upper or Lower Case Shell due to incorrect handling.

The factory assembly of the CM-DX1000 cosmetics is rather tight, and on the upper side, both major parts are held together by claws.

- Remove the Antenna.
- Remove the Battery Cover and the Battery.
- Remove the SIM Card Holder.
- Remove four screws in the Battery Compartment.
- Hold the set in your hand with the display side in the palm of your hand.
- Take the Lower Case Shell at its bottom part (i.e. bottom of the Battery Compartment) and lift this part to an angle of approximately 15°.
- Now rotate the Lower Case Shell clockwise. You will meet some resistance. A loud click will be audible (releasing of the claws) and the Lower Case Shell will be correctly loosened.
