# Rockwell- Collins | SERVICE BULLETIN

KWM-380 TRANSCEIVER (622-5093-101)  
HF-380 TRANSCEIVER (622-3580-101)  
RECEIVER-EXCITER CIRCUIT CARD A3 (638-6908-001)

SERVICE BULLETIN NO 1

PRODUCT IMPROVEMENT

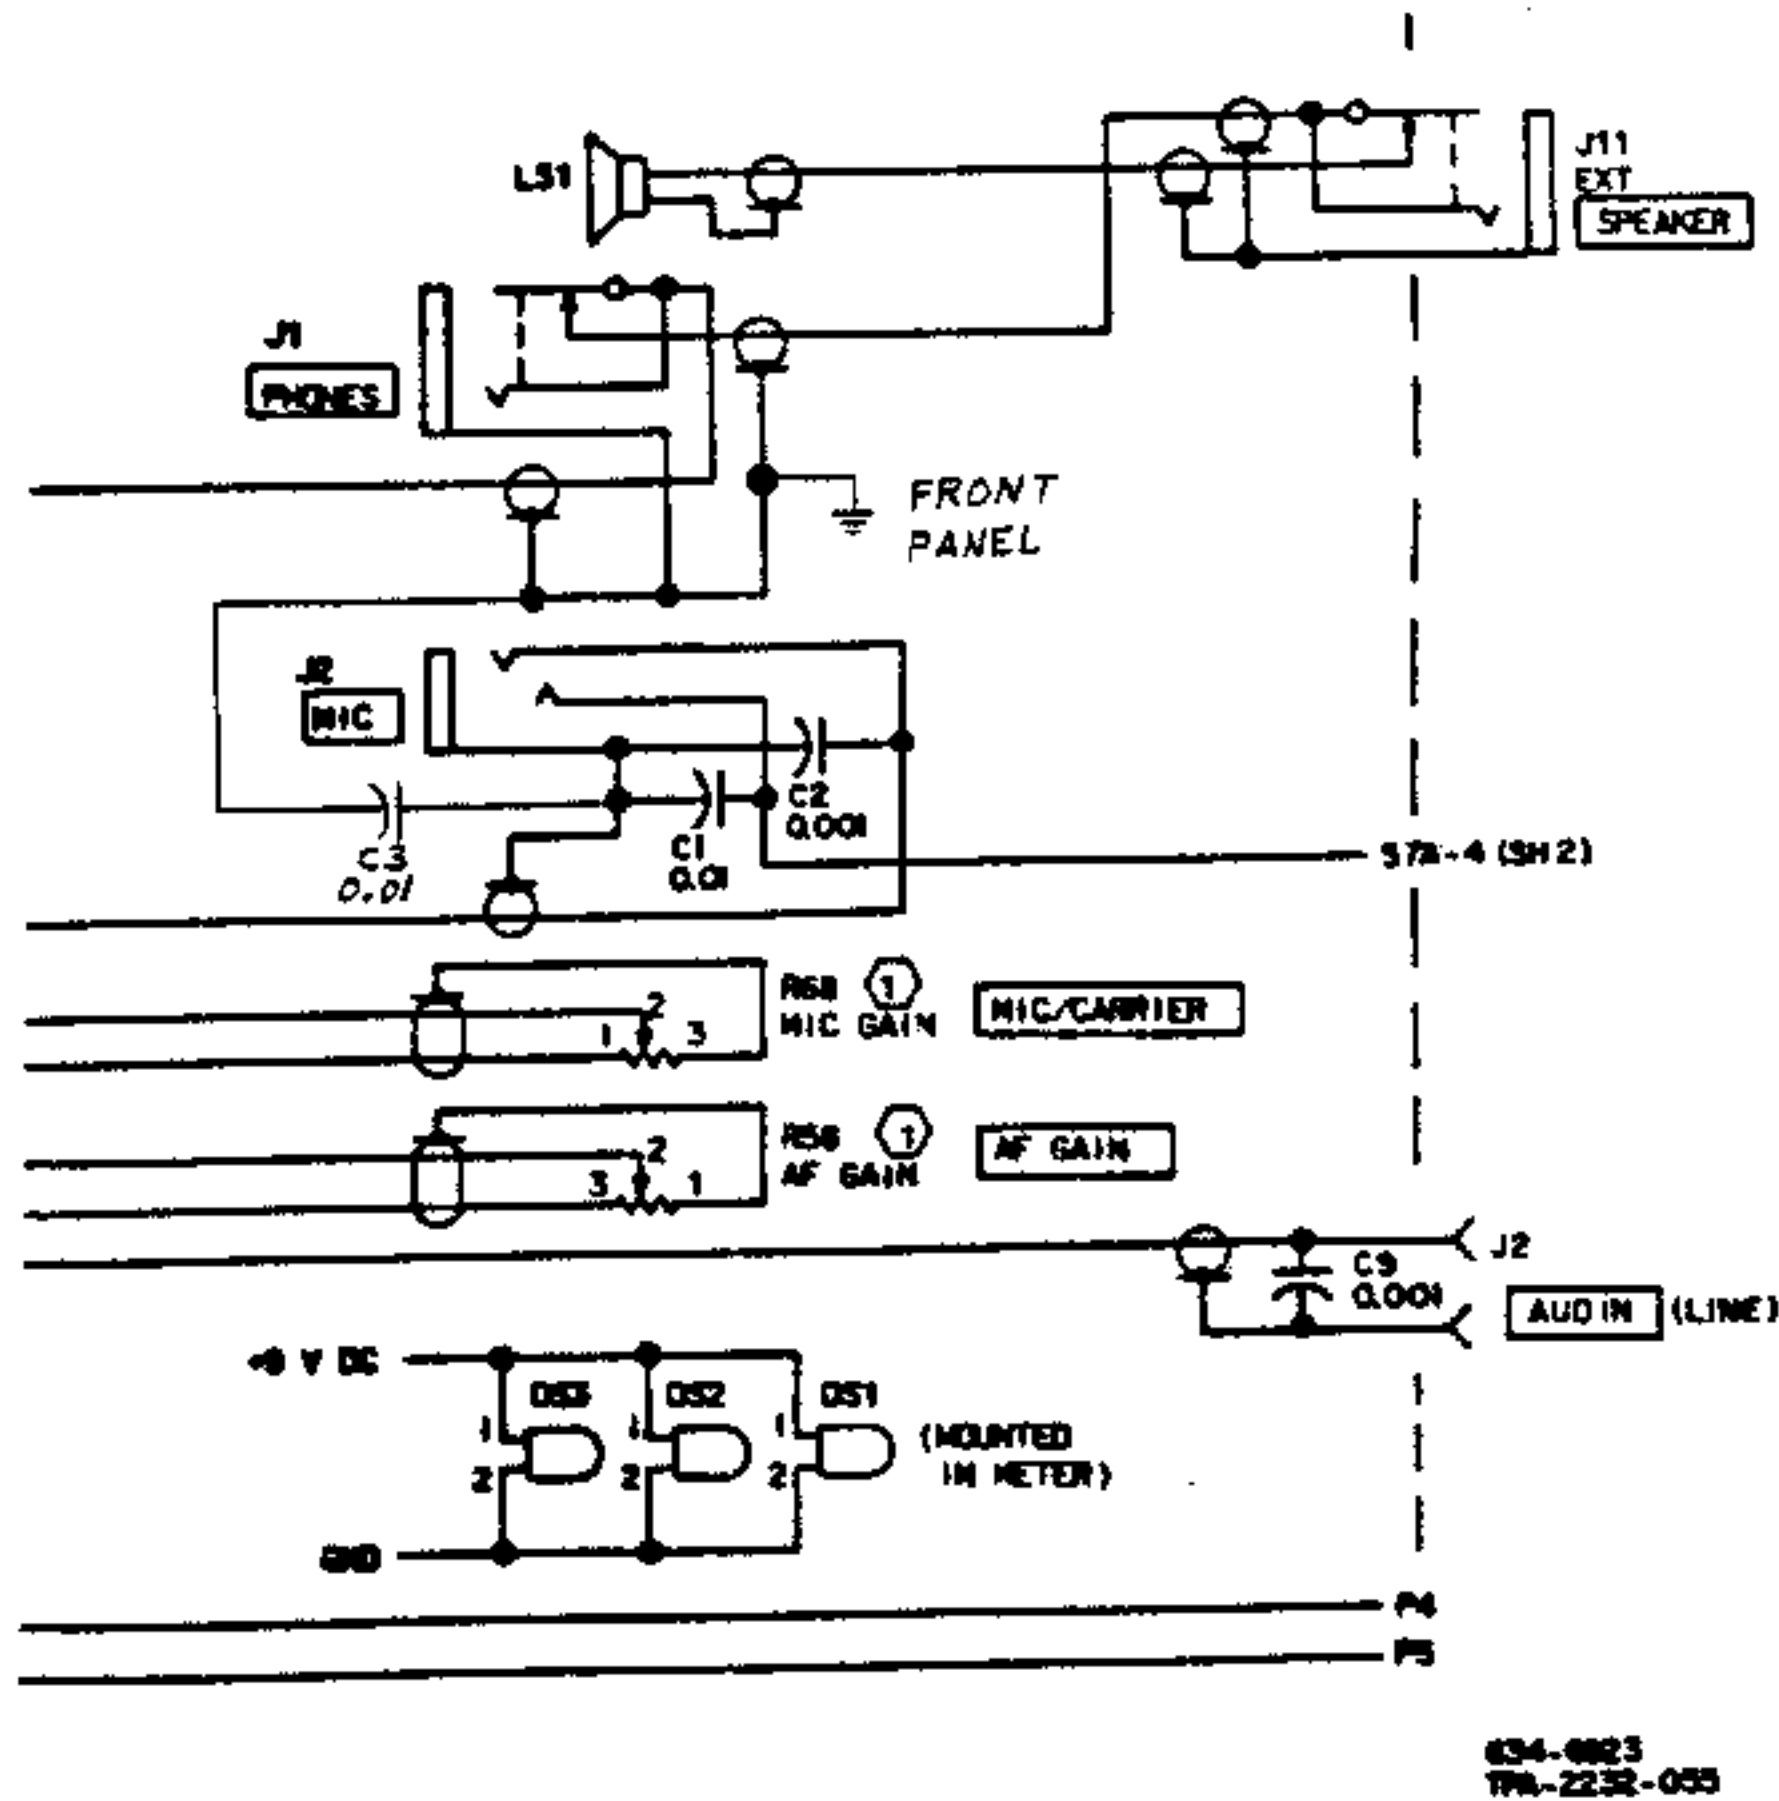
P/O KWM-380/HF-380 Interconnect Diagram  
Figure 3

The purpose of this service bulletin is to correct a transmit hum caused by a ground loop between the front panel and the receiver/exciter card ground plane.

This modification replaces the mic jack (J2) with a jack that has an insulated sleeve contact to break the ground loop.

NOTE: Refer to figure 3 for an interconnect diagram which includes the above changes.

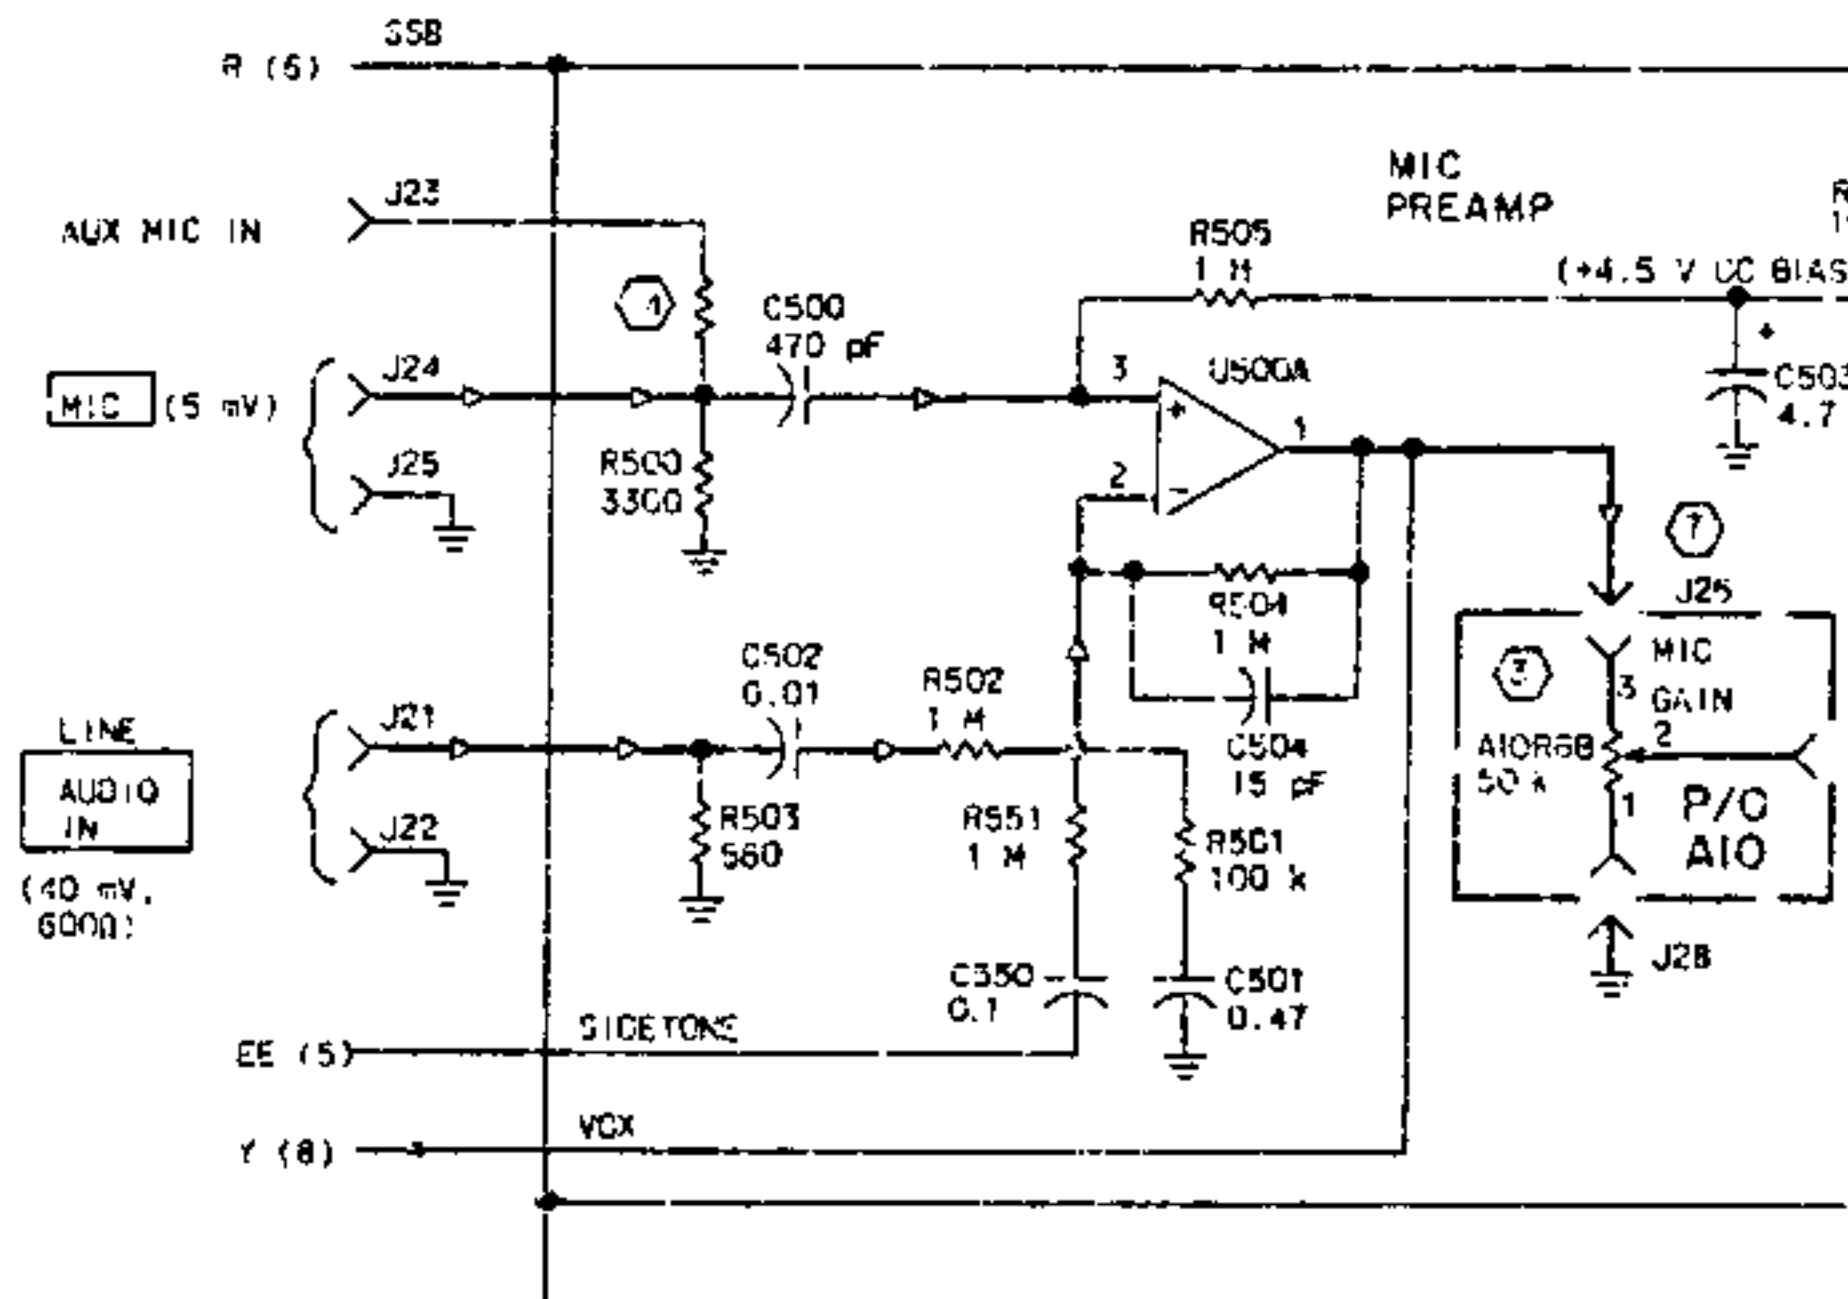
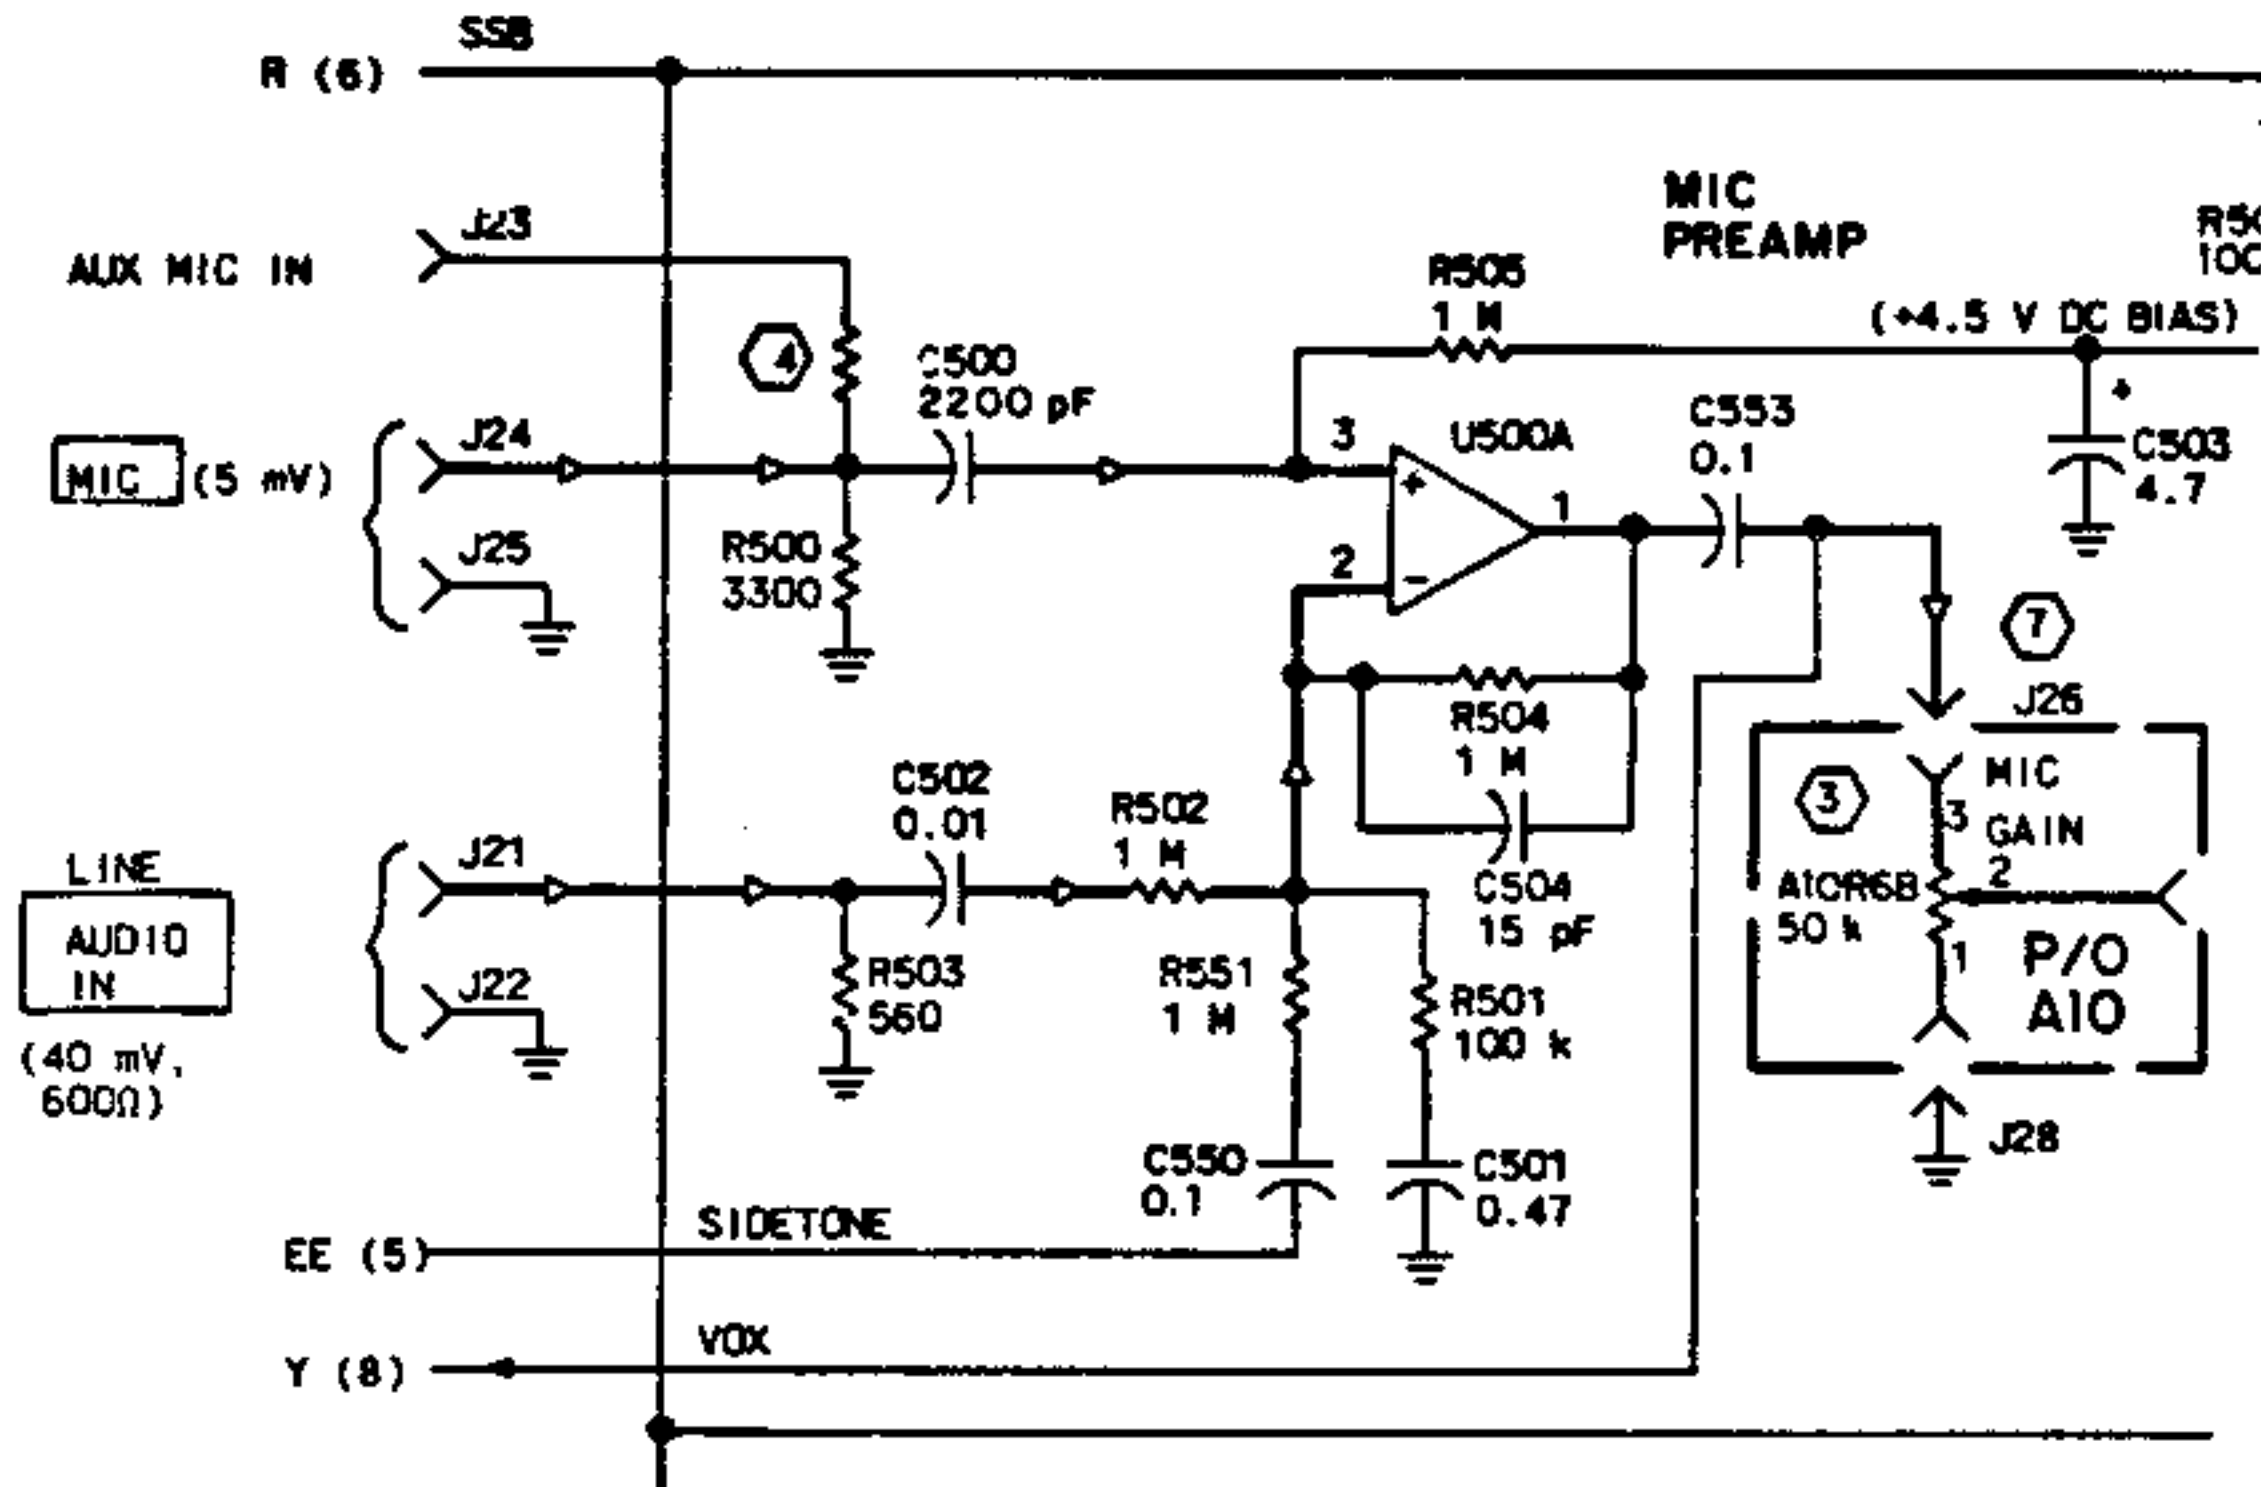
P/O Receiver-Exciter Assembly A3,  
Schematic Diagram  
Figure 3

BEFORE MODIFICATION

AFTER MODIFICATION

NOTE: Refer to figure 2 while performing steps F through H. Capacitor C553 is part of receiver-exciter assembly A3 but is mounted on front panel assembly A10. If C553 were mounted on the A3 card, a circuit trace cut on the bottom of the card would be required making it necessary to remove the card from the radio. Refer to figure 3 for a schematic diagram which shows the location of C553.
