Product Service Group CE Audio

Service Information

MCU & VCD BOARD

CHANGES DURING PRODUCTION

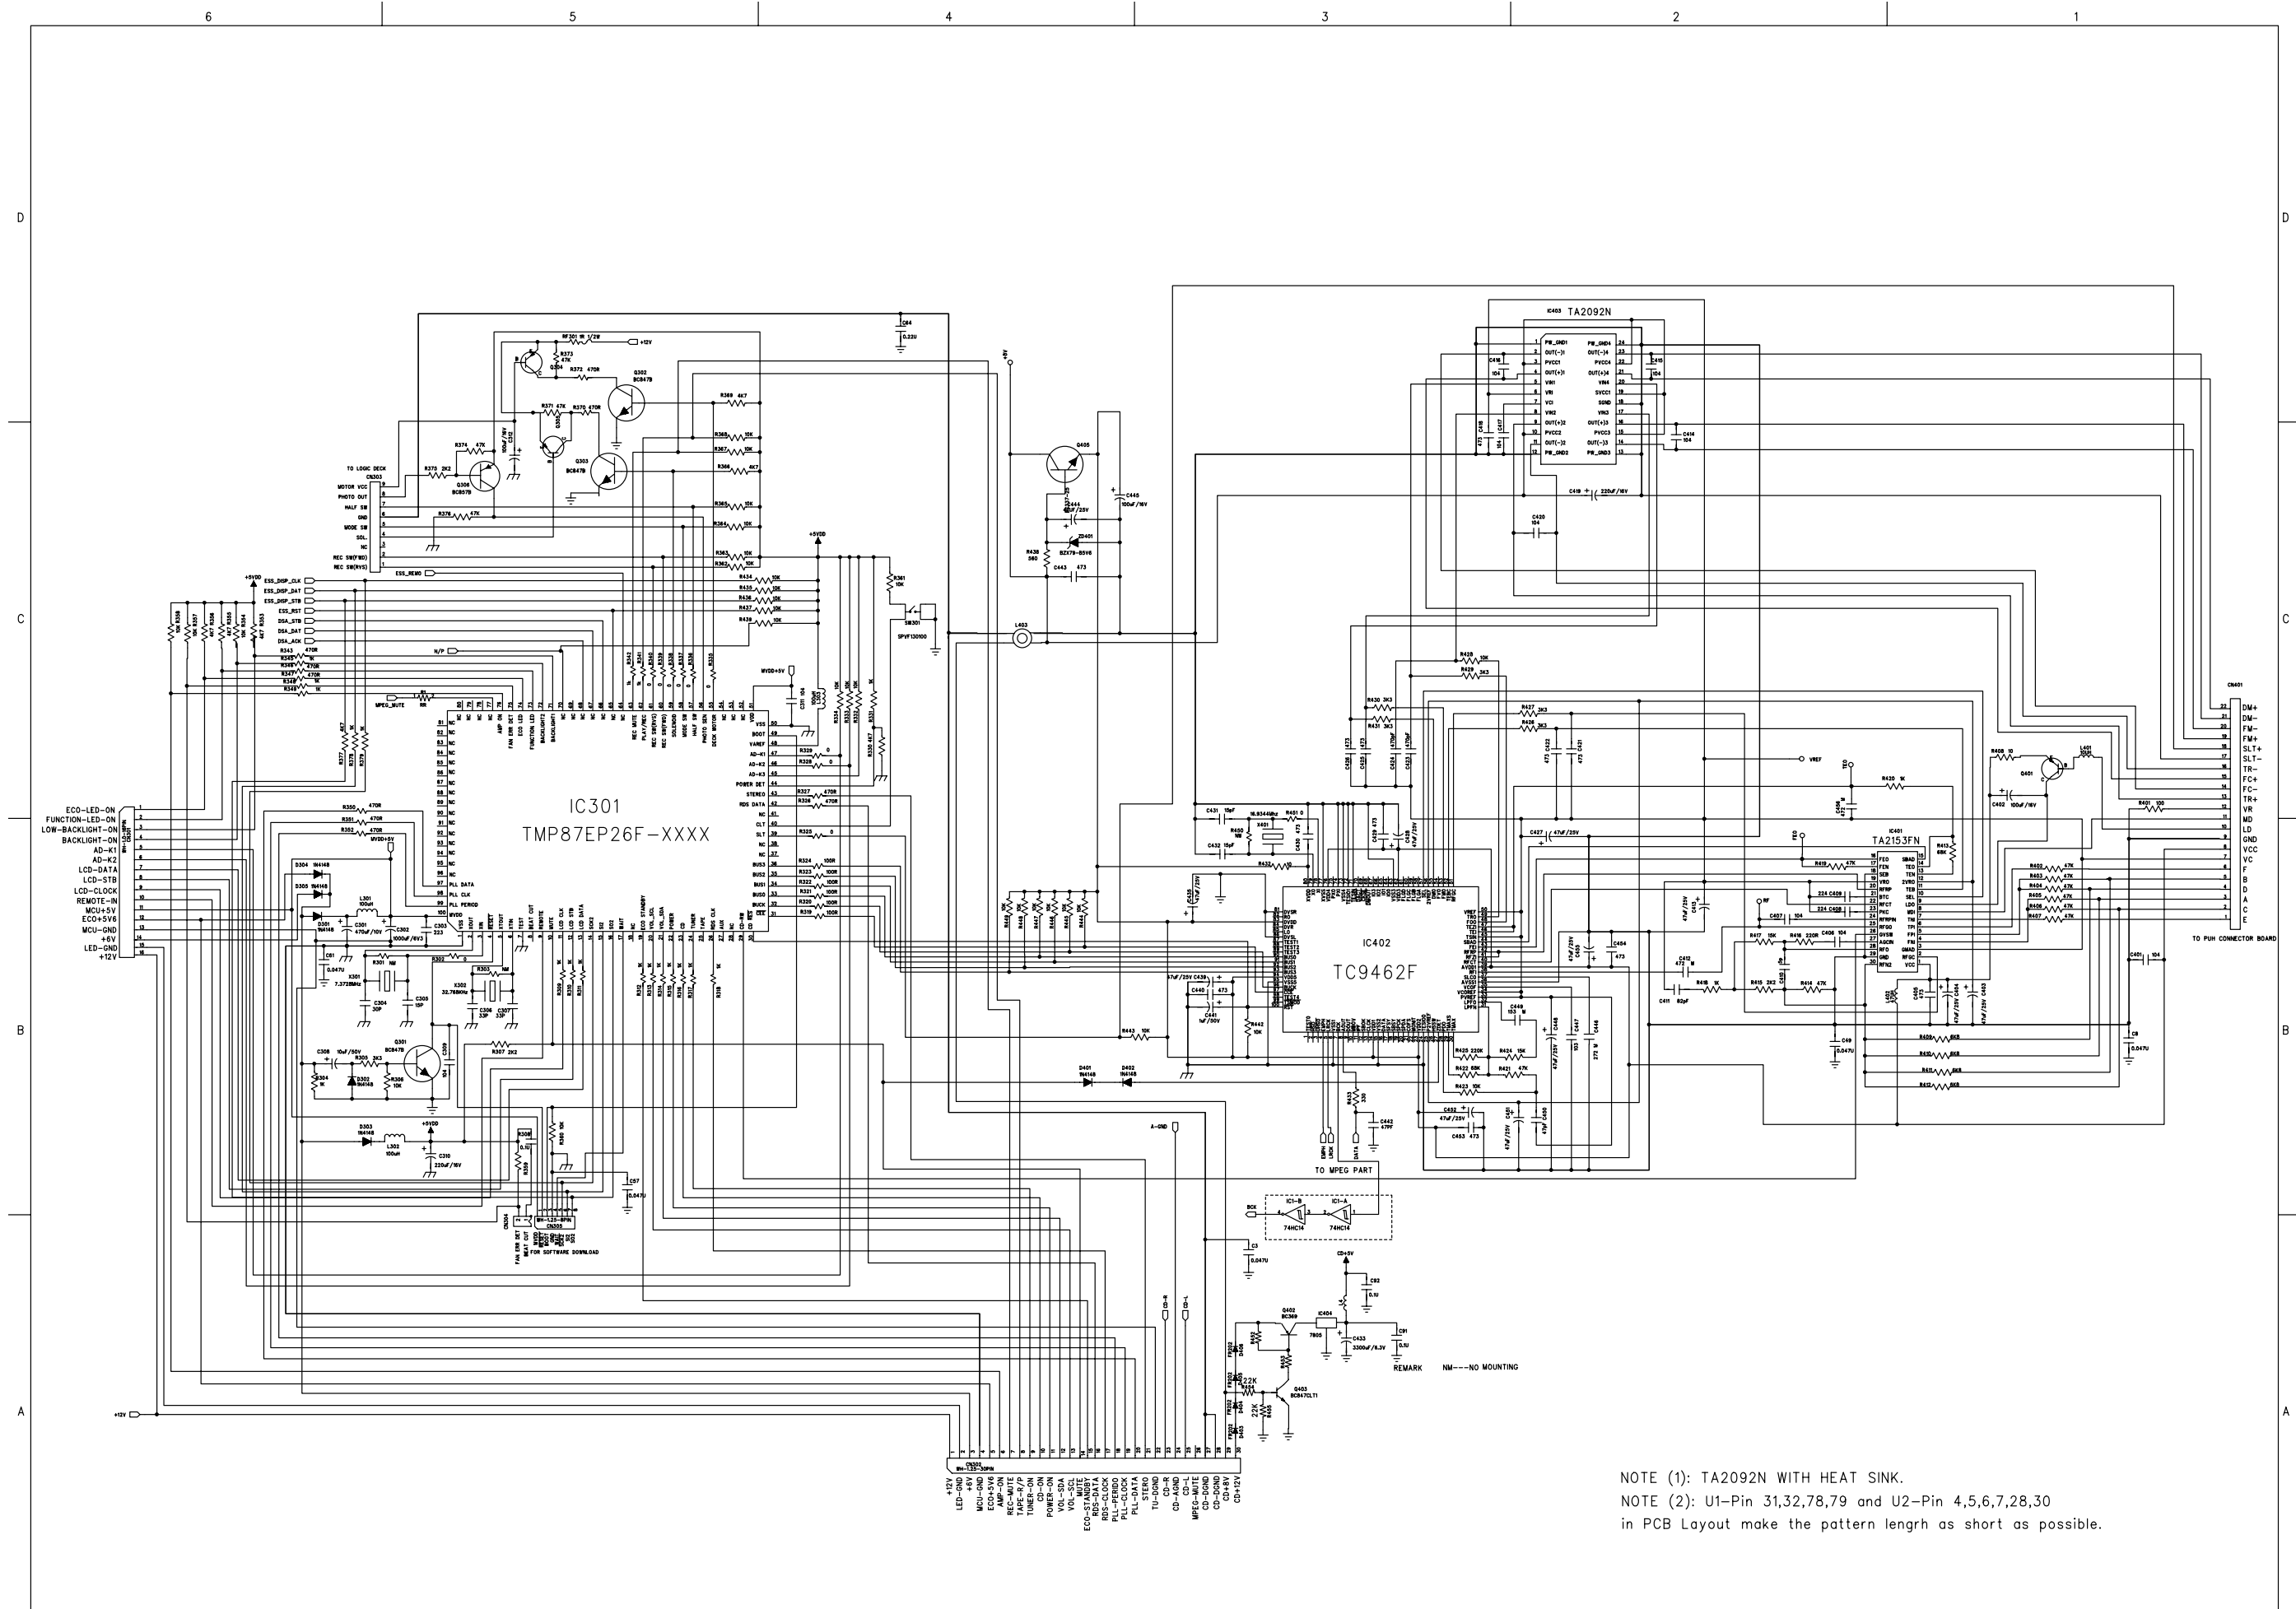
CIRCUIT DIAGRAM - MCU & VCD BOARD
Main Part

*From production week 0330 onwards the MCU & VCD board has been modified in order to eliminate the pink noise during CD playing.

Add IC1 5322 209 11548 MC74HC14AD

For servicing the new MCU & CD board, please refer to the attached pages.
