Product Service Group CE Audio

# Service Information

## **MCU & CD BOARD CHANGES DURING PRODUCTION**

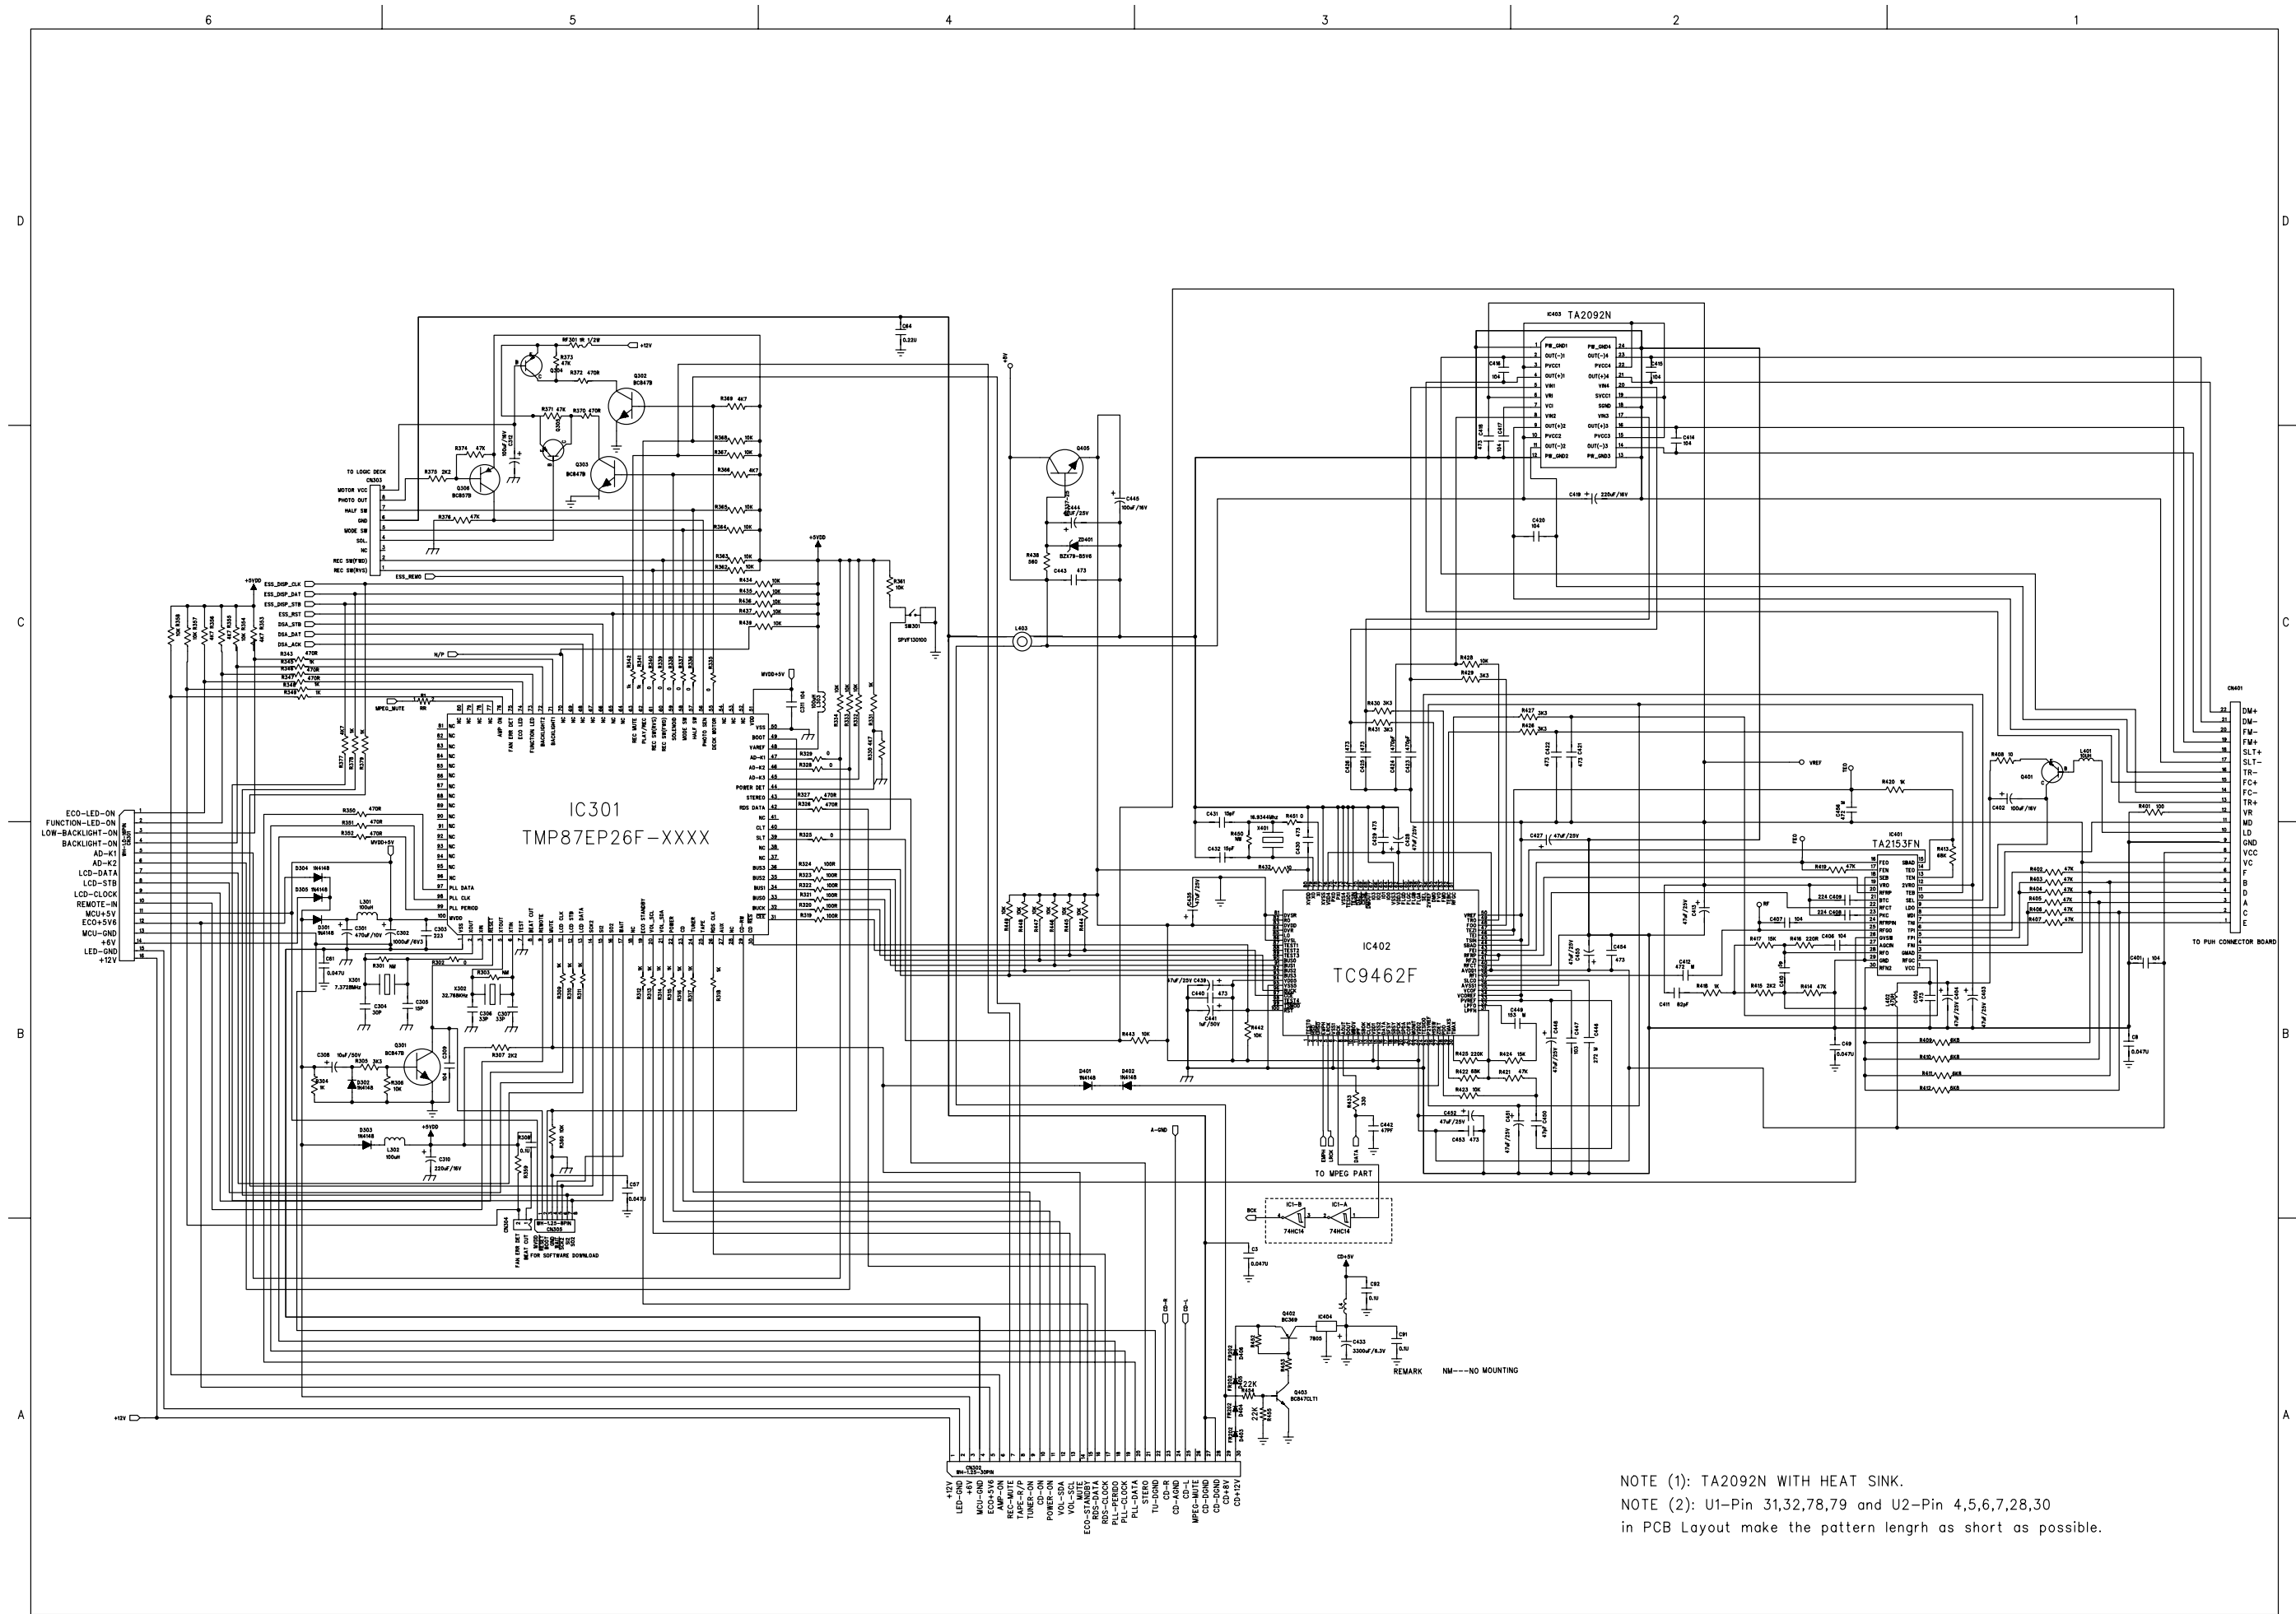
CIRCUIT DIAGRAM - MCU & CD BOARD  
Main Part

\*From production week 0330 onwards the MCU & CD board has been modified in order to eliminate the pink noise during CD playing.

Add IC1 5322 209 11548 MC74HC14AD

For servicing the new MCU & CD board, please refer to the attached pages.

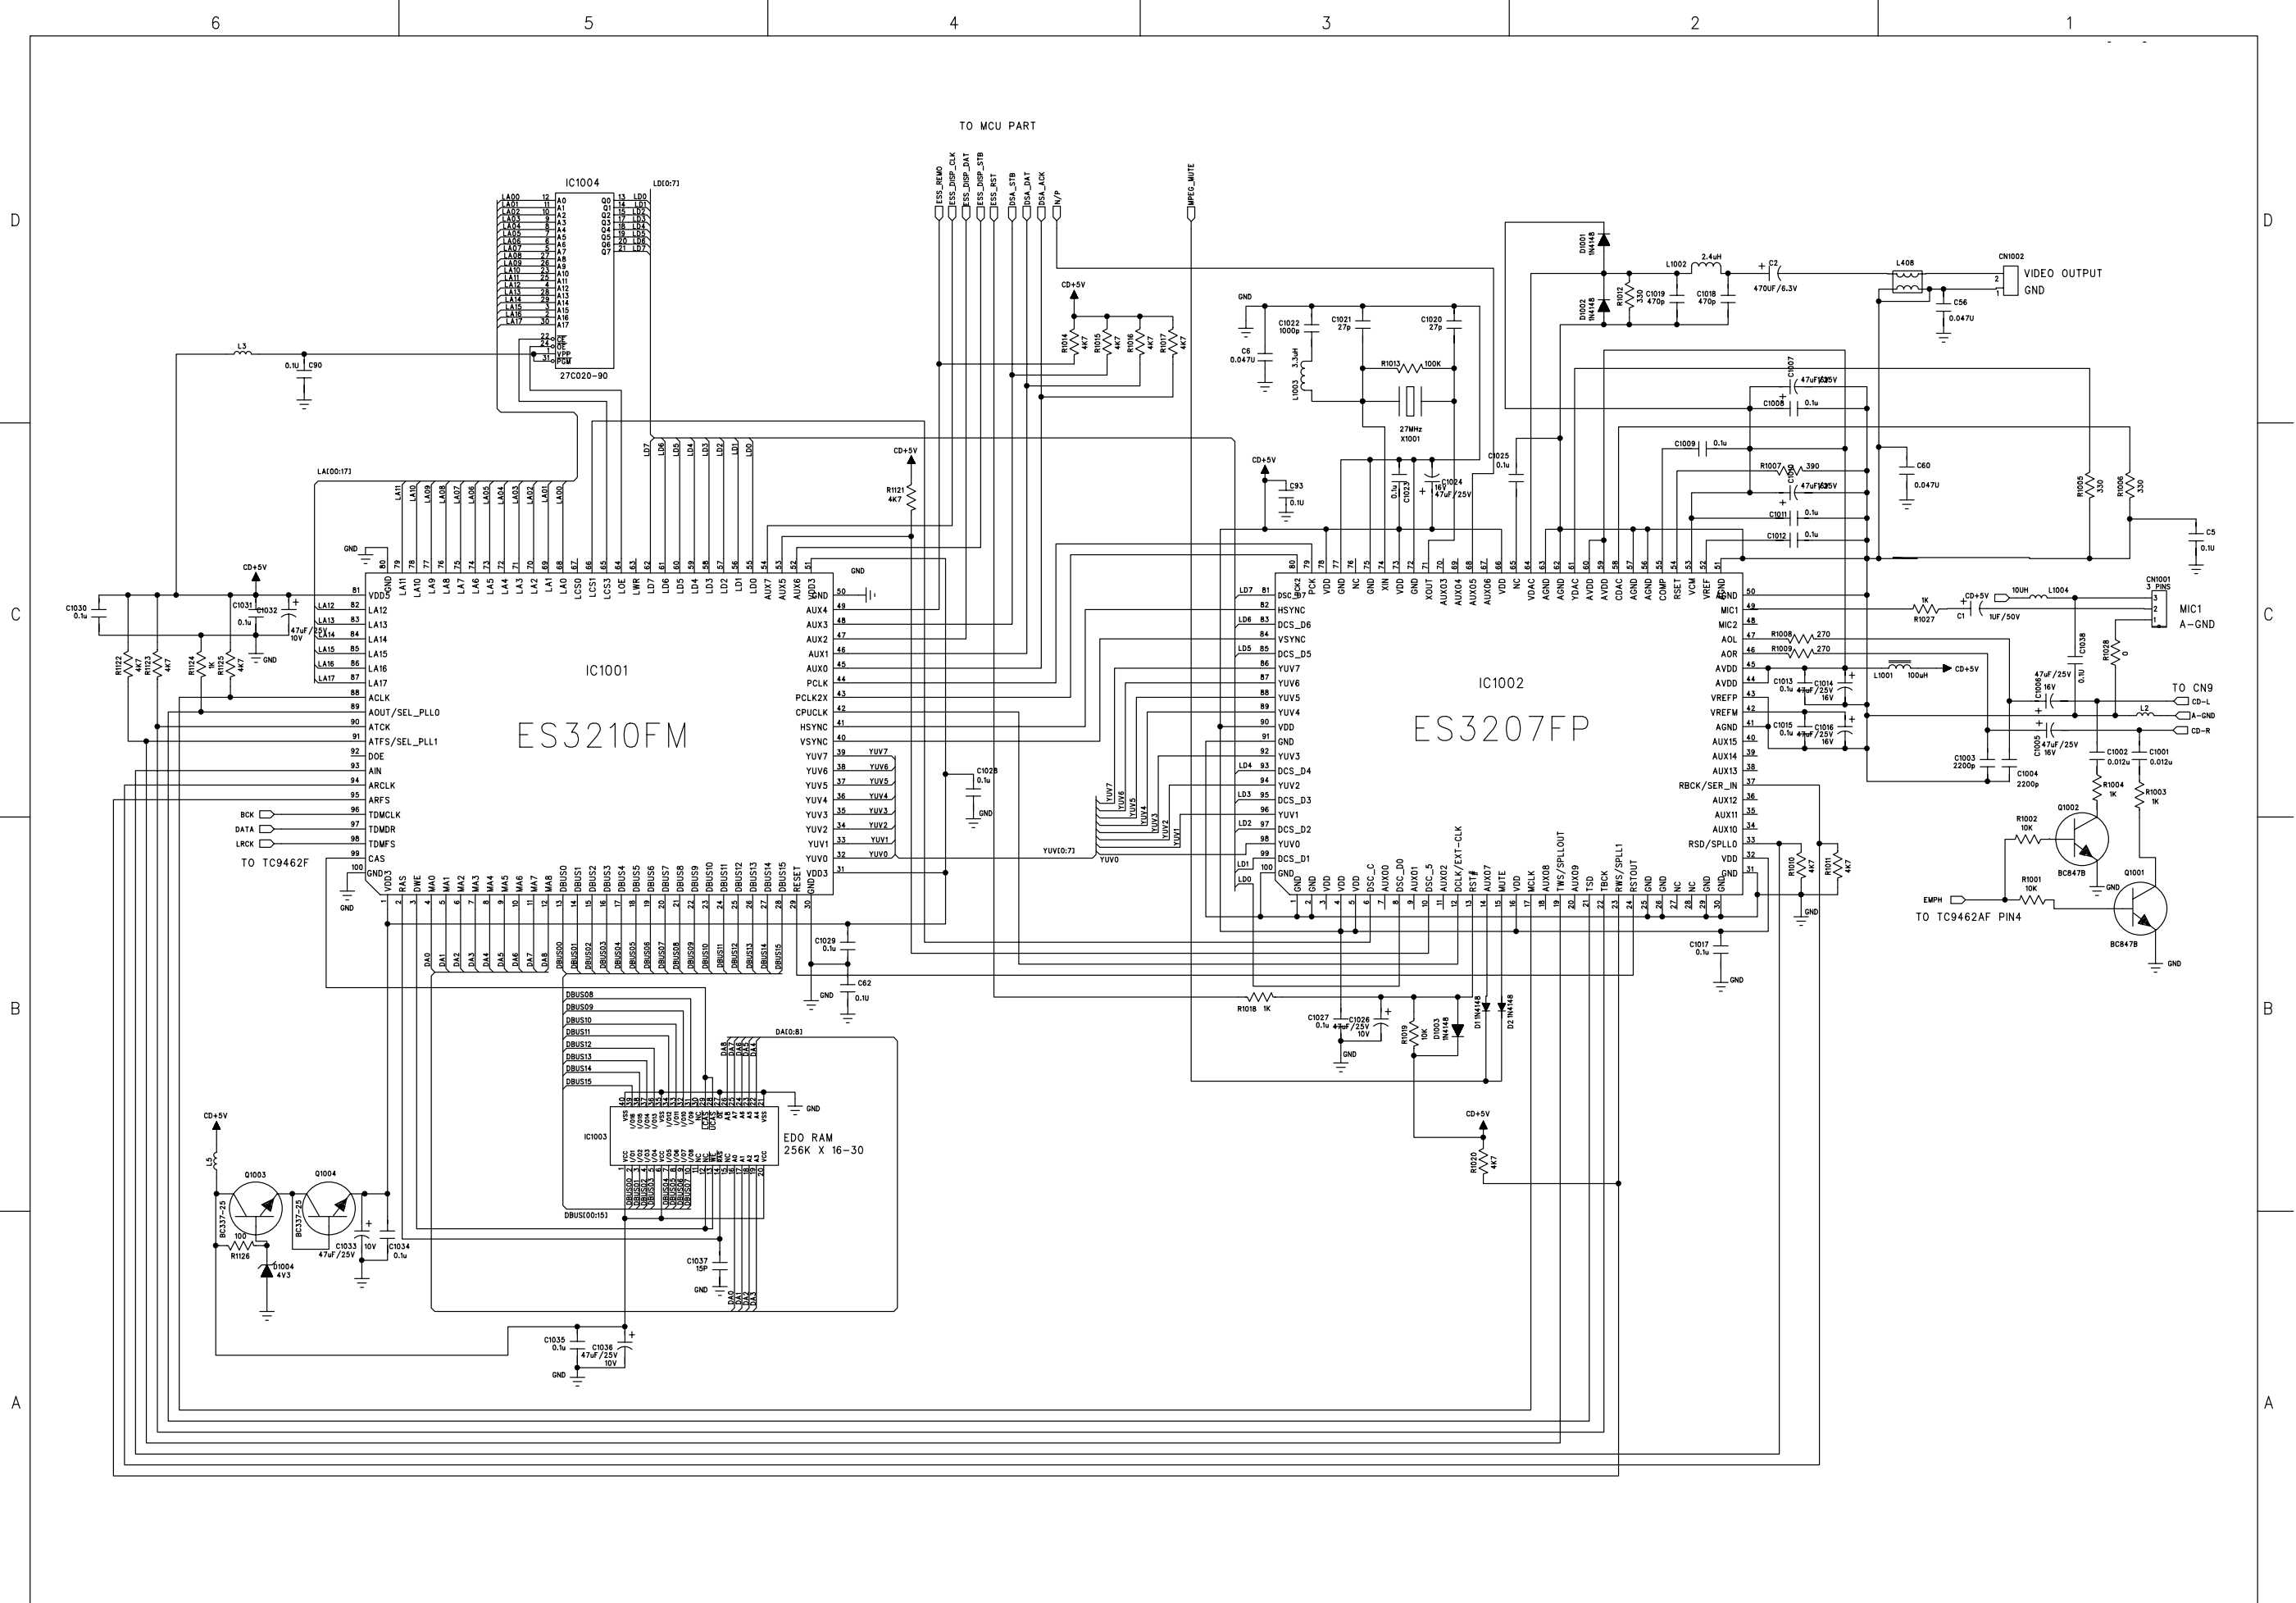
CIRCUIT DIAGRAM - MCU & CD BOARD  
MEPG Part

\*From production week 0330 onwards the following has been changed due to no need of video out.

Delete L1002 9965 000 19760 FIXED IND. 2.4UH /22/25
